SCHWEIZER SERVICE INFORMATION LETTER

REVISED NOTICE NO.: L-188a.

SUBJECT: 269A1231 MAIN ROTOR BEARING SET DELIVERED ON OR AFTER JUNE 17, 2021.

MODELS AFFECTED: 269A, 269A-1, 269B, 269C, 269C-1, AND 269D MODEL HELICOPTERS.

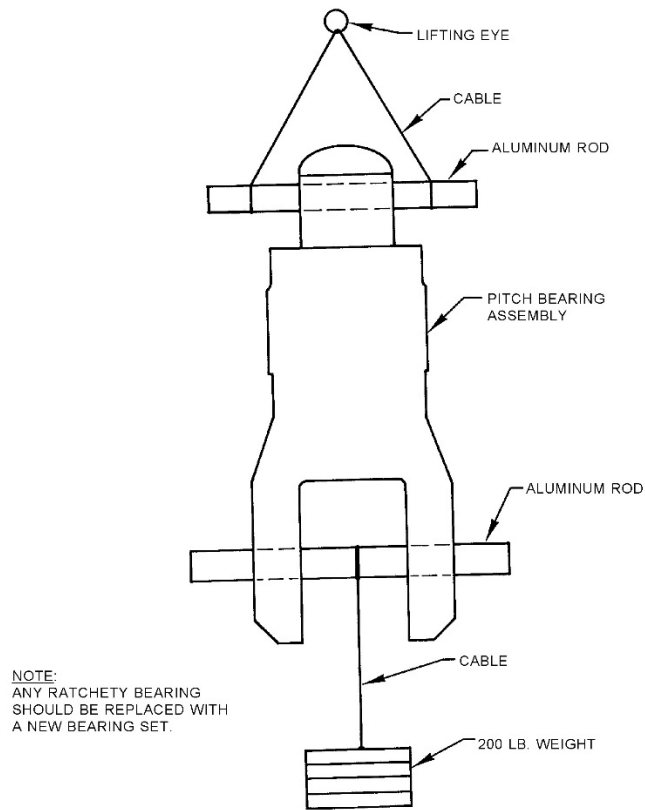
FIGURE 1 - "Inspection of Pitch Bearing Assembly"

HISTORICALLY THERE HAS BEEN SOME ISSUES WITH MAIN ROTOR BLADE PITCH BEARINGS AND BEARING LIFE. SOME 269 OWNERS HAVE EXPERIENCED A SHORT REPLACEMENT LIFE OF THE PITCH BEARINGS DUE TO A ROUGH ROTATION OR BRINELLING MARKS ON THE BEARING. IN AN EFFORT TO PROLONG BEARING LIFE, SCHWEIZER RSG (SRSG) HAS COMPLETED A THOROUGH EXAMINATION WITH A VARIETY OF SIKORSKY OLD STOCK AND SCHWEIZER NEW PITCH ASSEMBLIES. THE RESULT OF THIS EXAMINATION, HAS DISCOVERED THAT MOST BEARING MANUFACTURERS PRODUCE THESE BEARINGS WITH AN SLIGHT OFFSET BETWEEN THE BEARING'S INNER AND OUTER RACES. SRSG HAS RECORDED THE OFFSET BETWEEN THE BEARING BRANDS AND HAS DETERMINED THE MOST CONSISTENT BEARING MANUFACTURER AND HAVE COME UP WITH A SOLUTION TO EXTEND BEARING LIFE. UNFORTUNATELY, IT DOES NOT CORRECT ALREADY DAMAGED BEARINGS. WHEN REPLACING PITCH BEARING USING NEW BEARINGS DELIVERED ON OR AFTER JUNE 17, 2021, IT IS NECESSARY TO FOLLOW THE HMI SECTION 8-26 TO DETERMINE IF THERE IS AN ISSUE OF ROUGHNESS AFTER ASSEMBLY OR STICK VIBRATION DURING GROUND RUN UP. REFERENCE "NOTE" IN SECTION 8-26, PAGE 8-37. IF THIS CONDITION IS NOTICEABLE THERE IS A POSSIBILITY THAT THE 269A1205-BSC SPACER MAY NEED TO BE REPLACED.

(REF.: HMI FIGURE, "INSPECTION OF THE PITCH BEARING ASSEMBLY", FIGURE 8-23 IN CSP-C-2, FIGURE 8-18 IN CSP-C-10, CSP-C1-2 & CSP-D-9; FIGURE 8-17 IN CSP-D-2, AND FIGURE 9-18 IN MSP-D-15).

IF A BINDING OR RATCHETING IS DISCOVERED WITH THE NEW BEARINGS, SRSG HAS DEVELOPED A PROCEDURE FOR REPLACING THE EXISTING PITCH BEARING SPACER WITH A NEW, LONGER BEARING SPACER. FOR ALL NEW PURCHASES OF 269A1231 BEARINGS FROM THE ABOVE DATE AND THAT HAVE ISSUES OF BINDING AND RATCHETING, SCHWEIZER RSG WILL PROVIDE A NEW 269A1205 BEARING SPACER.

1. DISASSEMBLE AND CLEAN THE PITCH BEARING ASSEMBLY PER SECTION 8 OF THE HMI.
2. VERIFY THAT THE SERIAL NUMBER OF THE 269A1205 SPACER IS NOT SUCCEEDED BY THE LETTER "A". ANY SERIAL NUMBER SUCH AS, "S1234A", WILL HAVE ALREADY BEEN MODIFIED FOR THE NEW BEARINGS.
3. INSTALL NEW BEARINGS AND REASSEMBLE THE PITCH ASSEMBLY IN ACCORDANCE WITH THE HMI. NEW BEARINGS PURCHASED AFTER JUNE 17, 2021; CAN BE IDENTIFIED WITH THE MANUFACTURER MARKINGS - "ITB".
4. INSPECT PITCH ASSEMBLY IN ACCORDANCE WITH YOUR HMI SECTION TITLED: "FUNCTIONAL INSPECTION OF THRUST BEARINGS"
5. IF AN ISSUE IS FOUND CONTACT AND SUBMIT THE PITCH ASSEMBLY TO YOUR NEAREST SCHWEIZER APPROVED SERVICE CENTER.
