**HUGHES
SERVICE INFORMATION
LETTER**

LETTER NO. L-24
DATE May 5, 1967
PAGE 1 OF 2

SUBJECT: **PROPER HEIGHT OF CONTACT SPRINGS IN - 200
BENDIX MAGNETO DISTRIBUTOR BLOCK**

MODELS AFFECTED: All 269 Series Helicopters equipped with Lycoming
Engines using - 200 high tension magnetos.

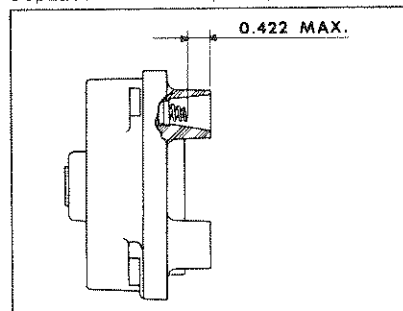
Figure 1

Contact springs of an insufficient height can cause arcing at the end of the spring. Carbon tracks then occur which induce cracks in the distributor block thus causing ignition system malfunctions.

Check height of all distributor block contact springs using a flush pin gage, small scale or other suitable measuring device. This dimension is determined by measuring from top of block outlet tower down to top of spring. Outlets in which the measurement is 0.422 inch or less contain acceptable contact springs. Outlets in which the measurement exceeds 0.422 inch contain springs which are defective or have been improperly installed (two bottom coils of spring caught in recessed groove of brass insert in block). Using a pointed instrument (scribe or etc.), wiggle top end of spring in a circular motion to be sure only the bottom turn of spring is captivated in groove of brass insert

in block. Recheck spring height in accordance with figure 1. If dimension still exceeds 0.422 inch, replace contact spring.
