HUGHES
SERVICE INFORMATION
LETTER

SUBJECT: INTERIM REVISION - HANDBOOK OF MAINTENANCE
INSTRUCTION (HMI) RE: SUDDEN STOPPAGE INSPECTION,
LATERAL CONTROL BELLCRANK, P/N 269A7506

MODELS AFFECTED: All 269 Series Helicopters

LETTER NO. L-44
DATE April 18, 1968
PAGE 2 OF 4

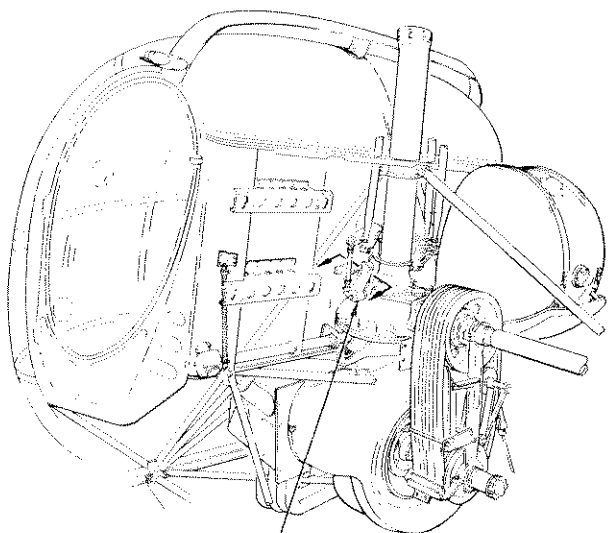
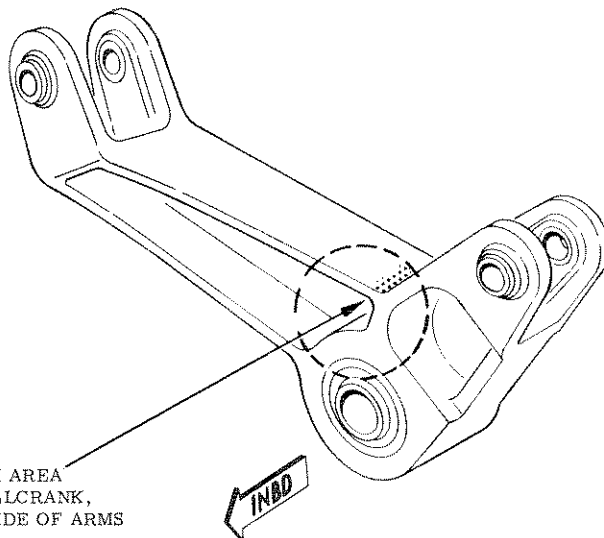
FIGURE 4-1A. INSPECTION - 269A7506 LATERAL PITCH MIXER IDLER BELLCRANK ASSEMBLY

269A7506 BELLCRANK ASSEMBLY

APEX AREA
OF BELLCRANK,
INBOARD SIDE OF ARMS

(3) Remove lateral control bellcrank (P/N 269A7506); visually inspect bellcrank for deformation or damage, using good light source and 6X minimum magnifying glass; dye penetrant inspect for cracks, paying particular attention to the inboard side of the bellcrank and the corner radii at the intersections of the bellcrank arms. (Refer to Figure 4-1A)

d. Remove and inspect (P/N 269A7506) bellcrank (22) for damage or deformation using good light source and 6X minimum magnifying glass; dye penetrant inspect for cracks, paying particular attention to the inboard side of the bellcrank and the corner radii at the intersections of the bellcrank arms. (Refer to Figure 4-1A)
