**SCHWEIZER
SERVICE
LETTER**

LETTER NO. L-63
DATE Nov. 1, 1971
PAGE 1 OF 1

SUBJECT: LYCOMING SERVICE BULLETIN NOS. 340 AND 341,
DATED AUGUST 27, 1971

MODELS AFFECTED: All 269 Series Helicopters

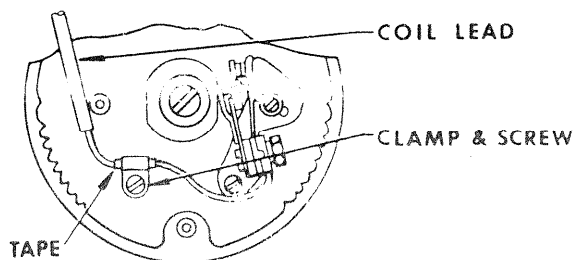
3/4 inch wide tape be wrapped around the lead to provide secure clamping.

Detailed Instructions:
Service experience indicates it is desirable to secure the coil to breaker primary lead in single breaker left hand rotation S-1200 Magnetos with a clamp as shown in sketch. Two different diameter primary leads have been used on the S-1200 series coils. For the smaller diameter lead it is recommended that a 1 inch piece of

- 1. Clamp 10-5752
- 1. Screw 10-35936-7
- * 1 inch of 3/4 inch wide #32 Scotch Tape

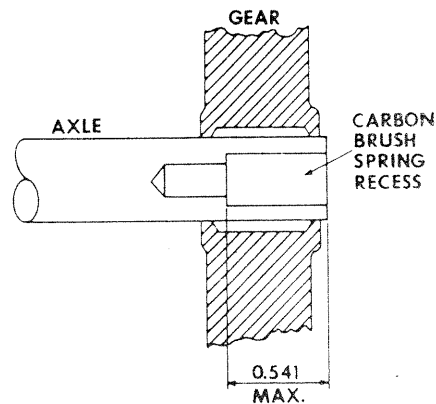
Figure 1.
S-1200 Distributor Gear Detail

Field reports indicate that some S-1200 magnetos presently in service have the locating shoulder for the carbon brush spring in the large distributor gear incorrectly positioned. This shoulder is either missing or is located deeper than the 0.541 inch maximum spring recess depth illustrated in figure 1.

Improper shoulder location allows the carbon brush to move too far within the axle, thus reducing brush tension against the coil tab and under certain conditions produces arc erosion on the tab face. Operational effect on magneto output is inconsequential, however it is recommended that any gear found with the shoulder out of dimension be removed from service.

Reject any gear assembly which has a shoulder incorrectly located. Repair any coil tab showing arc erosion following the procedure described in Bendix Service Bulletin No. 526B.

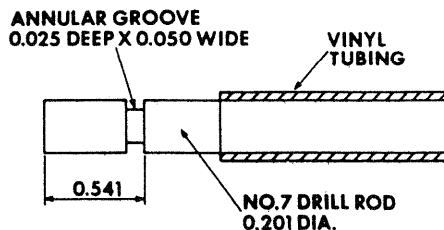
Figure 2.
Suggested Tool for Checking Carbon Brush Spring Recess Dimension

Shoulder location can be checked with Verniers or with a suggested tool which can be locally fabricated as illustrated in figure 2.

To check shoulder location, remove the carbon brush spring assembly, insert Verniers and measure for shoulder location or use the suggested tool. The 0.541 edge of the annular groove of the tool shall not disappear from view within the axle spring recess. Spare gear assemblies must be checked in a similar manner.
