HUGHES  
SERVICE INFORMATION  
LETTER

LETTER NO. L-68.1\*

SUBJECT: LYCOMING SERVICE BULLETIN NO. 336B, DATED 19 JUNE 1972; AND NO 343A, DATED 18 FEBRUARY 1972 - PERIODIC INSPECTION, LUBRICATION AND PARTS REPLACEMENT FOR BENDIX S4LN-1208 MAGNETOS

MODELS AFFECTED: All Model 269C Helicopters

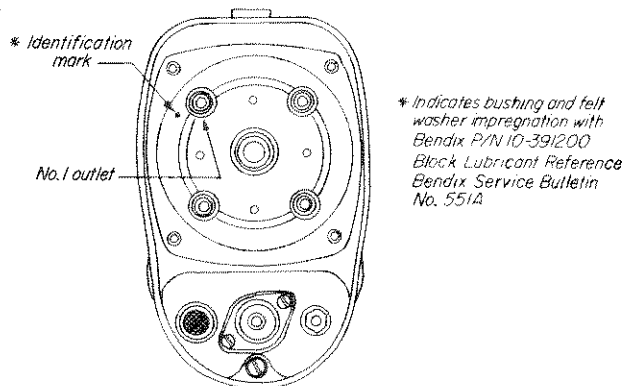
Figure 1. Location of Identification Mark

Distributor blocks may or may not have the identification mark shown in figure 1. The following lubrication instructions apply in either case.

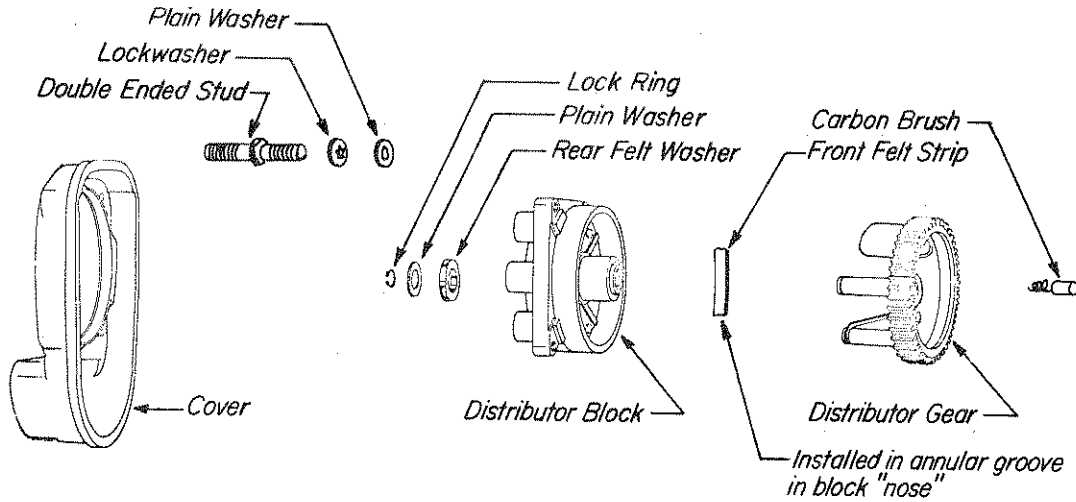
Figure 2. Partial Exploded View Showing Relative Location of Parts

7. Carefully inspect distributor gear for cracks, chipping or excessive tooth wear. Look for a concentration of yellow discoloration on the molding compound near its point of attachment to the shaft. (This could mean overheating has occurred in this area.) Observe shaft for discoloration or galling. (Shaft surface should be silver bright.) Gear exhibiting any of the above should be replaced.

6. Separate the distributor block and gear by removing lock ring. See figure 2.

10. Assemble distributor gear to block (reverse of part 6).

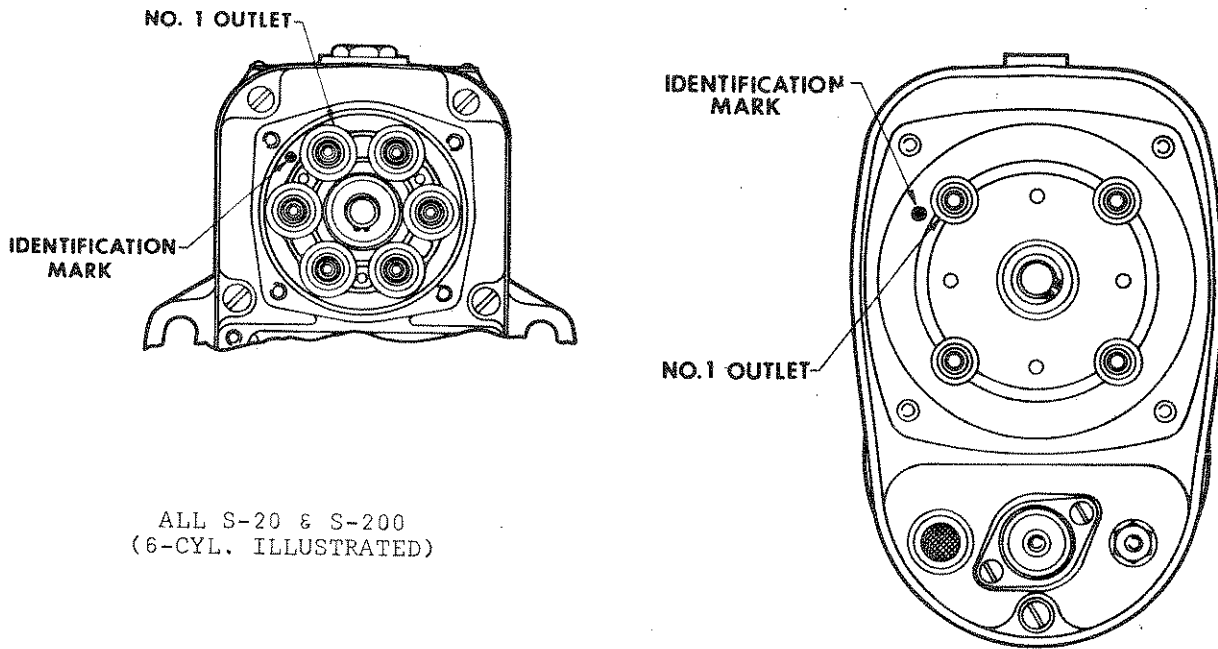
(a.) A boss (raised material) on the distributor block to the left and adjacent to the #1 High Tension Tower.

(b.) An indentation (drill point) .125" dia. .016" deep in the same location as in (a.).

1. Distributor block bronze bushings that have been impregnated with the new lubricant\* are identified by either of two methods. (See (a.) or (b.) and Figure 1.).

DISTRIBUTOR BLOCKS AS VIEWED FROM OUTLET END OF MAGNETO

(e.) Identify reworked distributor blocks by drilling a hole .125" dia. and .016" deep as shown in Figure 1.
