SCHWEIZER SERVICE NOTICE

NOTICE NO. N-142.1

SUBJECT: INITIAL INSTALLATION OF PN 269A5194 MAIN ROTOR DRIVE RING GEAR CARRIER ASSEMBLY; MODIFICATION OF PN 269A5182 MAIN GEAR DRIVE UPPER HOUSING ASSEMBLY

MODELS AFFECTED: All Model 269 Series Helicopters equipped with 269A5175 Basic, 269A5175-3 or 269A5175-5 Main Gear Drive Assembly

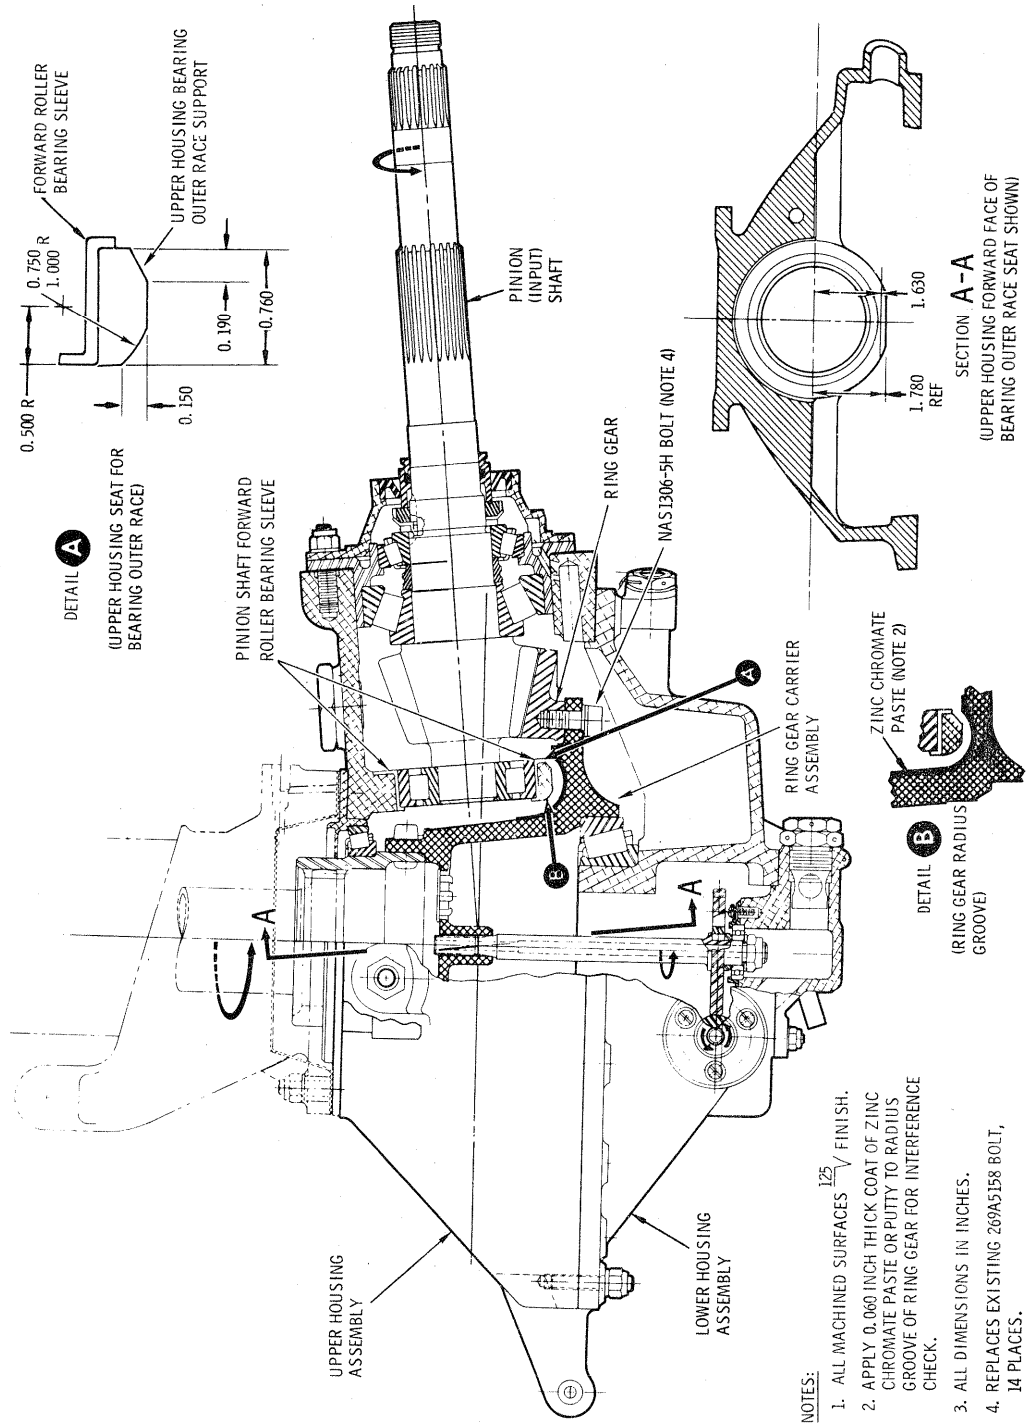
Figure 1. Rework of Main Gear Drive Upper Housing Assembly, PN 269A5182

The 269A5194 assembly is comprised of a 269A5193 carrier and 269A5112 coupling. Since the new carrier is designed with greater dimensional thickness, a modification of the upper housing is required to preclude interference between the new carrier and the forward roller bearing outer race seat in the upper housing. In addition, new and longer NAS1306-5H bolts are used as replacement for existing 269A5158 bolts when installing the 269A5194 ring gear carrier assembly.

a. Locate rework area on the lower front face of the upper housing seat for the pinion forward roller bearing outer race. (See Figure 1.) Mill housing bearing support per dimensions shown; dichromate treat the reworked area of housing, per Basic HMI, Section 2.

1. With 269A5105 lower housing right side up on bench, position 269A5194 ring gear and carrier in place in lower housing.
2. Apply a 0.060 inch thick coat of zinc chromate paste (or putty) to cover full circumference of radius groove in ring gear, as shown in Figure 1.
3. Position reworked 269A5182 upper housing in place on lower housing; position 269A5114 cover (without 269A5102 shim) in place on upper housing.
4. While applying hand pressure on cover to preload bearings, rotate ring gear 360° several times; separate upper and lower housings and remove ring gear and carrier assembly.
5. Check coat of zinc chromate paste (or putty) for evidence of contact or interference between the upper housing and carrier assemblies.

If less than 0.030 clearance exists, repeat step a and step b.2 through step b.5 above.
