HUGHES SERVICE INFORMATION NOTICE

NOTICE NO. N-151.2*
DATE 7 November 1978
PAGE 1 OF 6

SUBJECT: INSPECTION - MAIN TRANSMISSION PINION ASSEMBLY, PN 269A5103-9

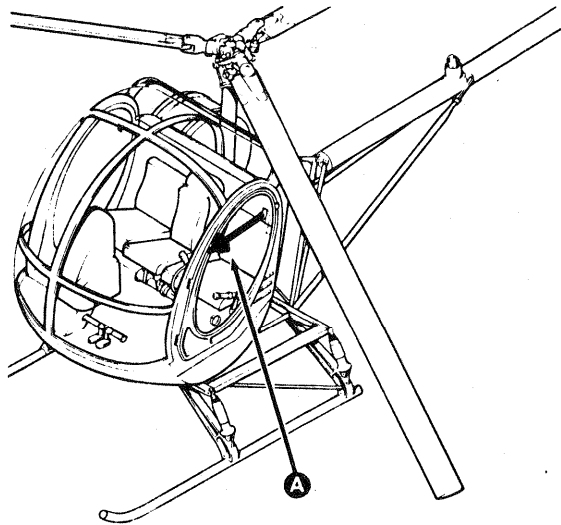
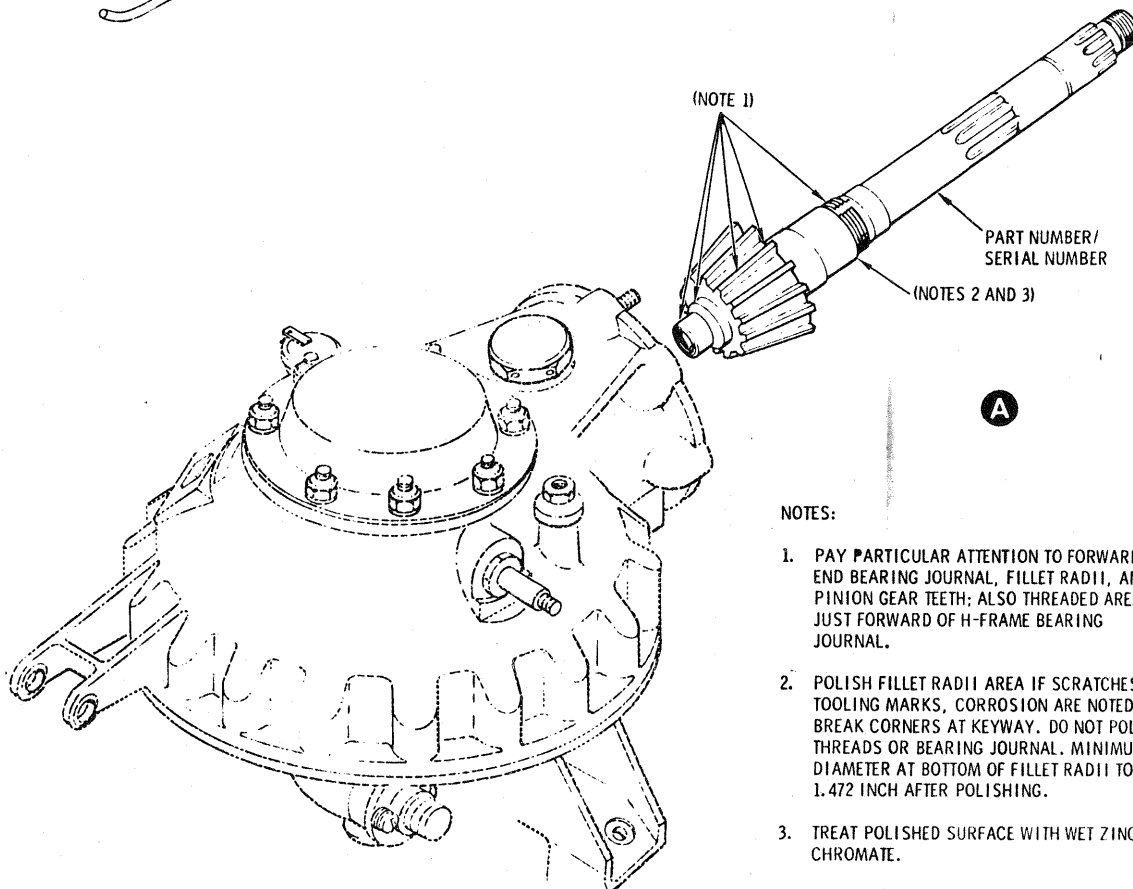
Figure 1. Inspection of Main Transmission Pinion Assembly
Wet Zinc Chromate

PREFACE: Field service reports indicate that evidence of cracking has been detected in two pinion assemblies manufactured by Hughes Tool Company. The information given in this Service Information Notice lists instructions for identification of PN 269A5103-9 pinion assemblies, installed and in Spares Inventory; and for magnetic particle inspection of pinion assemblies identified as being manufactured by HTC, to ensure that these pinion assemblies are free of cracks and are serviceable.

c. Clean pinion assembly. Using 10X glass, visually inspect pinion for scratches, tooling marks, corrosion or other surface defects. Pay particular attention to area of fillet radii of forward bearing journal. (See Figure 1.)

d. Clean pinion assembly and perform magnetic particle inspection of entire pinion in accordance with MIL-I-6868. Pay particular attention to forward end of bearing journal and fillet radii, pinion gear teeth, and threaded area just forward of H-frame bearing journal. (See Figure 1.) If no defects are found, treat polished area with wet zinc chromate.

1. Position pinion on lathe or equivalent rotating fixture.
2. Polish out defect(s) on pinion as it is rotated on lathe or fixture. Use fine emery cloth wrapped around tongue depressor for polishing. Extra fine arkansas or carborundum stone may be used provided diameter of stone matches radius. Break corners at keyway. Do not polish pinion threads or bearing journal.

1. If magnetic particle inspection indication is noted in area polished per step c above, repolish and repeat magnetic particle inspection of the area. If indication cannot be removed by repolishing, or the minimum diameter at the bottom of the fillet radius after polishing is less than 1.472 inches, mark and tag the pinion as unserviceable and return pinion to HH Warranty and Repair Department.

1. PAY PARTICULAR ATTENTION TO FORWARD END BEARING JOURNAL, FILLET RADIUS, AND PINION GEAR TEETH; ALSO THREADED AREA JUST FORWARD OF H-FRAME BEARING JOURNAL.
2. POLISH FILLET RADIUS AREA IF SCRATCHES, TOOLING MARKS, CORROSION ARE NOTED. BREAK CORNERS AT KEYWAY. DO NOT POLISH THREADS OR BEARING JOURNAL. MINIMUM DIAMETER AT BOTTOM OF FILLET RADIUS TO BE 1.472 INCH AFTER POLISHING.
3. TREAT POLISHED SURFACE WITH WET ZINC CHROMATE.
