HUGHES SERVICE INFORMATION NOTICE

NOTICE NO. N-16.1

FIELD MODIFICATION - TAIL ROTOR ASSEMBLY

All 269 Series Helicopters

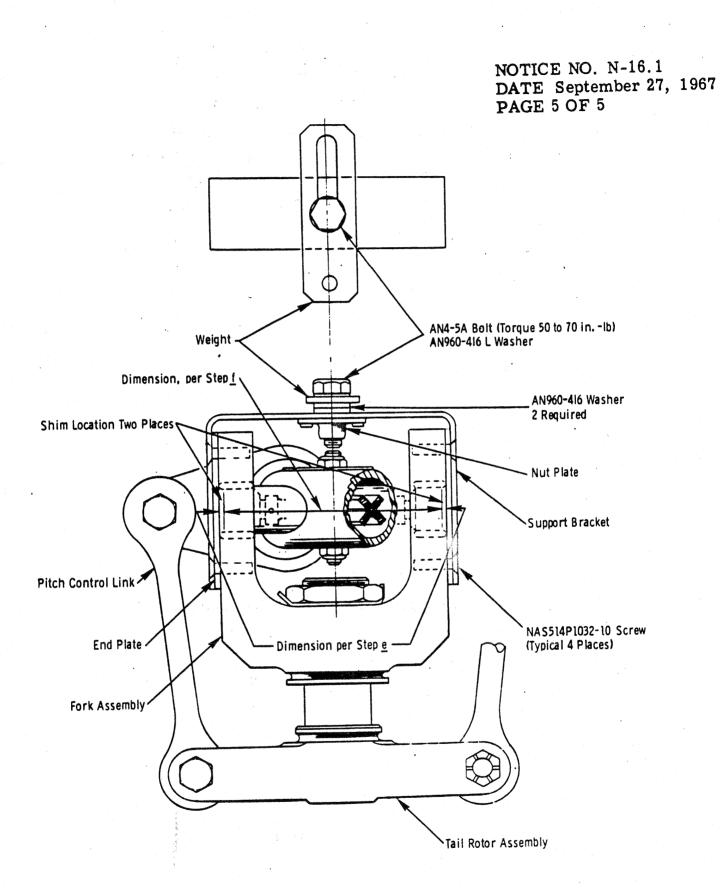
FIGURE 1. BALANCE WEIGHT INSTALLATION

The information given in this Service Information Notice lists a convenient method for obtaining a fine balance adjustment of the tail rotor assembly to remedy an out of balance condition.

e. Using micrometer, measure and record dimension across two flats of fork assembly. (See Figure 1)

m. Position balancing weight support bracket over two end plates. (See Figure 1.)

p. Secure balance weight assembly to support in following sequence: bolt, thin washer, weight, two washers; torque bolt 50 to 70 in. lbs.

Position weight perpendicular to support so weight is equidistant on each side of support.
