# HUGHES SERVICE INFORMATION NOTICE

NOTICE NO. N-17

SUBJECT: FIELD MODIFICATION - FUEL INJECTION SYSTEM

MODELS AFFECTED: 269A (TH55A) Helicopter Serial No's. 0315 through 0667,

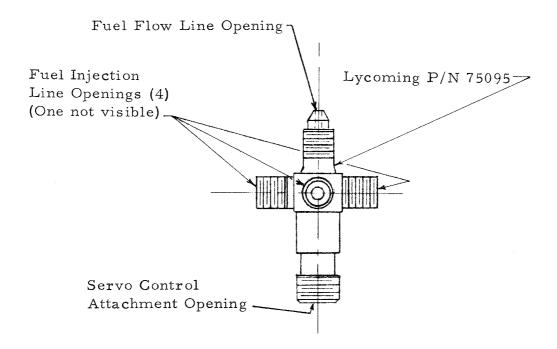
Figure 1.
Rosette Fitting

PURPOSE: To minimize the effect of the fuel flow gage installation

Procedure 1. given in this notice defines the proper method of altering the orifice of the rosette fitting, which does not affect the gage calibration. Slower fuel flow gage response will be noted after this

- a. Determine that all electrical power on the rotorcraft is shut down.
- b. Determine that fuel shut off valve and mixture control are closed.
- c. Disconnect five fuel lines from rosette fitting.
- d. Remove rosette fitting from servo control.
- e. Using solvent, thoroughly clean and degrease interior and exterior of fitting and allow to dry.
- f. Secure fitting in vise or other suitable holder with hole to be resized pointing down.
- g. Add solder to inside of fitting, heat with soldering iron or torch at low flame.

- h. Insert deburred music wire through molten solder.
- i. Remove heat, allow solder to harden and fitting to cool.

- j. Carefully remove music wire from rosette fitting.
- k. Remove fitting from vise; using solvent thoroughly clean fitting and allow to dry.
- 1. Inspect fitting; determine that there are no obstructions blocking injection line ports or ports into injector.

An alternate method of modification is to fill orifice with solder as noted, then drill new passage using 18 mm jewelers bit.

- m. Reinstall rosette fitting in reverse order of removal.
- n. Pressurize fuel system, check installation for leaks.
