# SCHWEIZER SERVICE NOTICE

NOTICE NO. N-179.1\*

SUBJECT: INSPECTION AND RETIREMENT — PN 269A5179 and 269A5179-3 DRIVE SHAFT AND COUPLING ASSEMBLY, MAIN ROTOR GEAR DRIVE ASSEMBLY PN 269A5175 BASIC, -3 OR -5

MODELS AFFECTED: All Model 269 Series Helicopters equipped with subject Main Rotor Gear Drive Assembly incorporating PN 269A5179 or 269A5179-3 Drive Shaft and Coupling Assembly

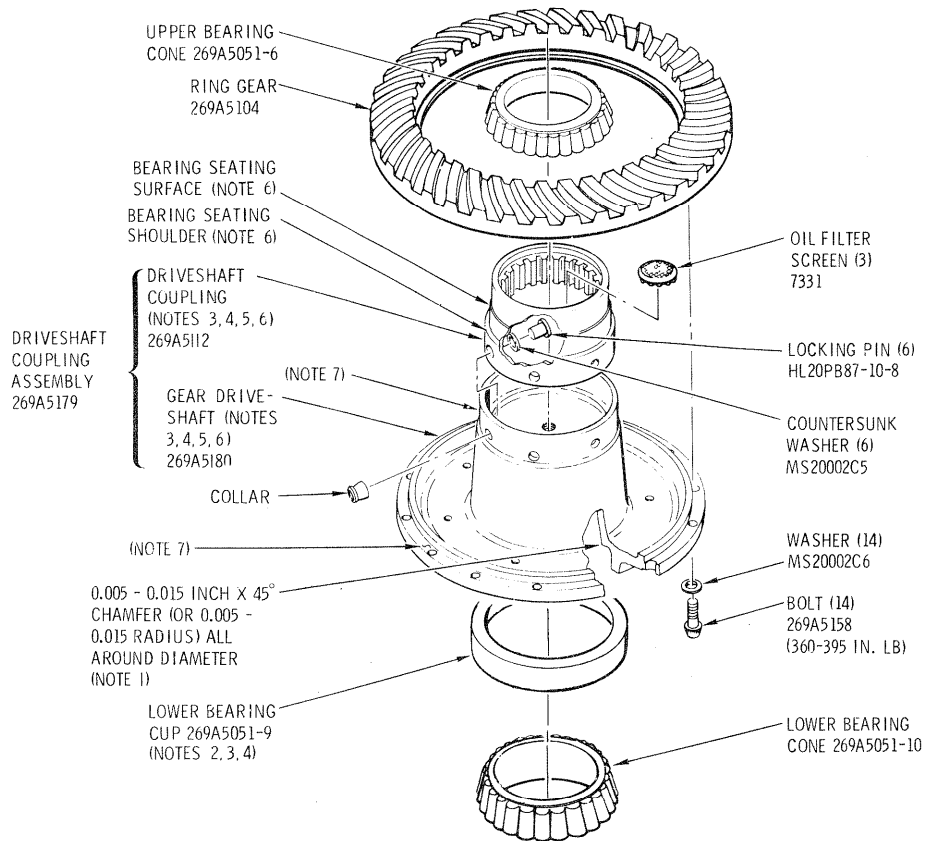
Figure 1. Drive shaft coupling assembly -- exploded view

1. INSPECT FOR SHARP EDGE. IF SHARP EDGE IS PRESENT, REMOVE MATERIAL FOR REQUIRED CHAMFER (OR RADIUS). (REFER TO TEXT.)
2. CUP TO SHAFT INTERFERENCE FIT OF 0.007 IN. MINIMUM TO 0.009 IN. MAXIMUM REQUIRED. (FOR DIAMETER REQUIREMENTS REFER TO TEXT.)
3. INSTALL WITH ZINC CHROMATE PRIMER.
4. REMOVE OR INSTALL USING TEMPERATURE DIFFERENCE METHOD. (REFER TO TEXT.)
5. PRIOR TO DISASSEMBLY, PAINT MARK ON EACH COMPONENT FOR REASSEMBLY AT SAME POSITION.
6. AFTER REASSEMBLY OF SHAFT AND COUPLING, CHECK COUPLING-TO-SHAFT ALIGNMENT. (REFER TO TEXT.)
7. AFTER INSPECTION OF COUPLING IN SHAFT, APPLY ZINC CHROMATE PRIMER TO CIRCUMFERENCE AT COUPLING AND SHAFT.

c. If a sharp edge exists at shoulder inside diameter (ID) of lower bearing cup seat on drive shaft, remove sharp edge with a stone or 100 grit (or finer) emery cloth. Remove approximately 0.005 to 0.010 inch of material. (See Figure 1.)
