SCHWEIZER SERVICE NOTICE

NOTICE NO. N-182
DATE 26 MAY 1982
PAGE 1 OF 4

SUBJECT: PERIODIC INSPECTION OF IDLER PULLEY SUPPORT BRACKET ASSEMBLY, PN 269A5575 AND PN 269A5575-3

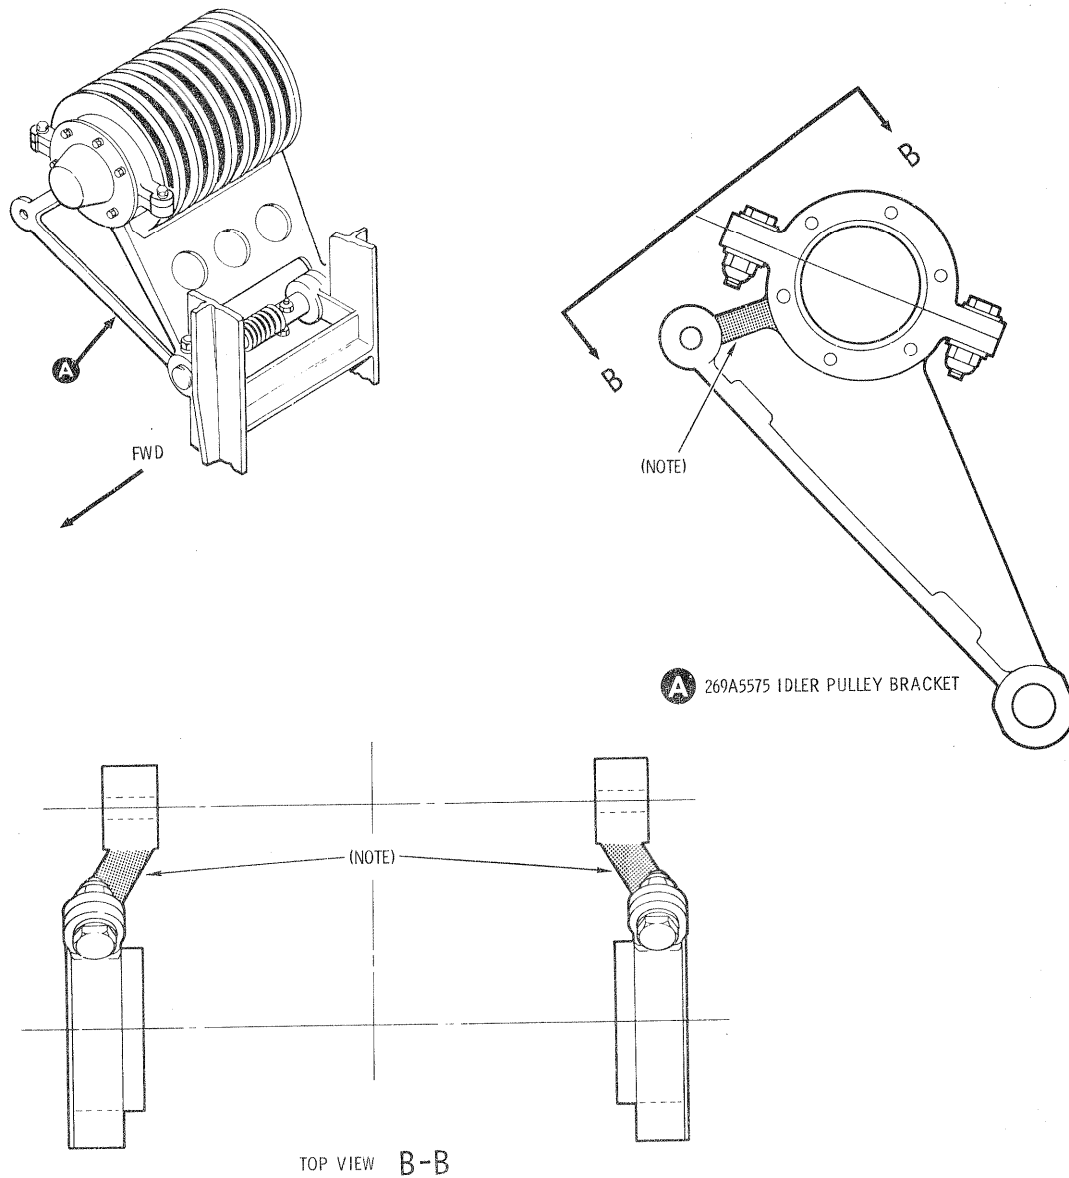
Figure 1. Inspection of Idler Pulley Support Bracket Assembly

- a. Remove V-belt drive cover from belt drive transmission. (Refer to Section 10 of Basic HMI.)
- b. Using bright light and 10X magnifying glass, closely inspect the entire top area and both sides of FWD and AFT bracket arms (see Figure 1) for cracks or damage. Pay particular attention to the top inside corner of bracket arm between the clutch spring boss and bearing boss as shown. Clean and wipe bracket arms free of dirt, grime, etc, prior to visual inspection. Removal of paint from bracket arms not required.

NOTE:
INSPECT SHADED AREAS OF FWD AND AFT BRACKET
ARMS FOR CRACKING. CLOSELY INSPECT (WITH 10X GLASS) ENTIRE TOP
AND SIDE AREAS OF BRACKET ARMS; PAY PARTICULAR ATTENTION TO
TOP INSIDE CORNER AREA BETWEEN CLUTCH SPRING AND BEARING BOSSES

If cracking of bracket arm is noted, replace bracket with new PN 269A5575-3 idler pulley support bracket assembly. Notify HMI Customer Service Department of any bracket where cracking is found.
