SCHWEIZER SERVICE NOTICE

NOTICE NO. N-183.3*
DATE: 15 Sept 1989
Page 1 of 8

SUBJECT:

- PILOT PREFLIGHT CHECK OF TAIL ROTOR BLADE LEADING EDGE ABRASION STRIP.
- DETAILED INSPECTION OF TAIL ROTOR BLADE LEADING EDGE ABRASION STRIP BONDING.
- INSTALLATION OF RIVETS ON TAIL ROTOR BLADE LEADING EDGE ABRASION STRIP.

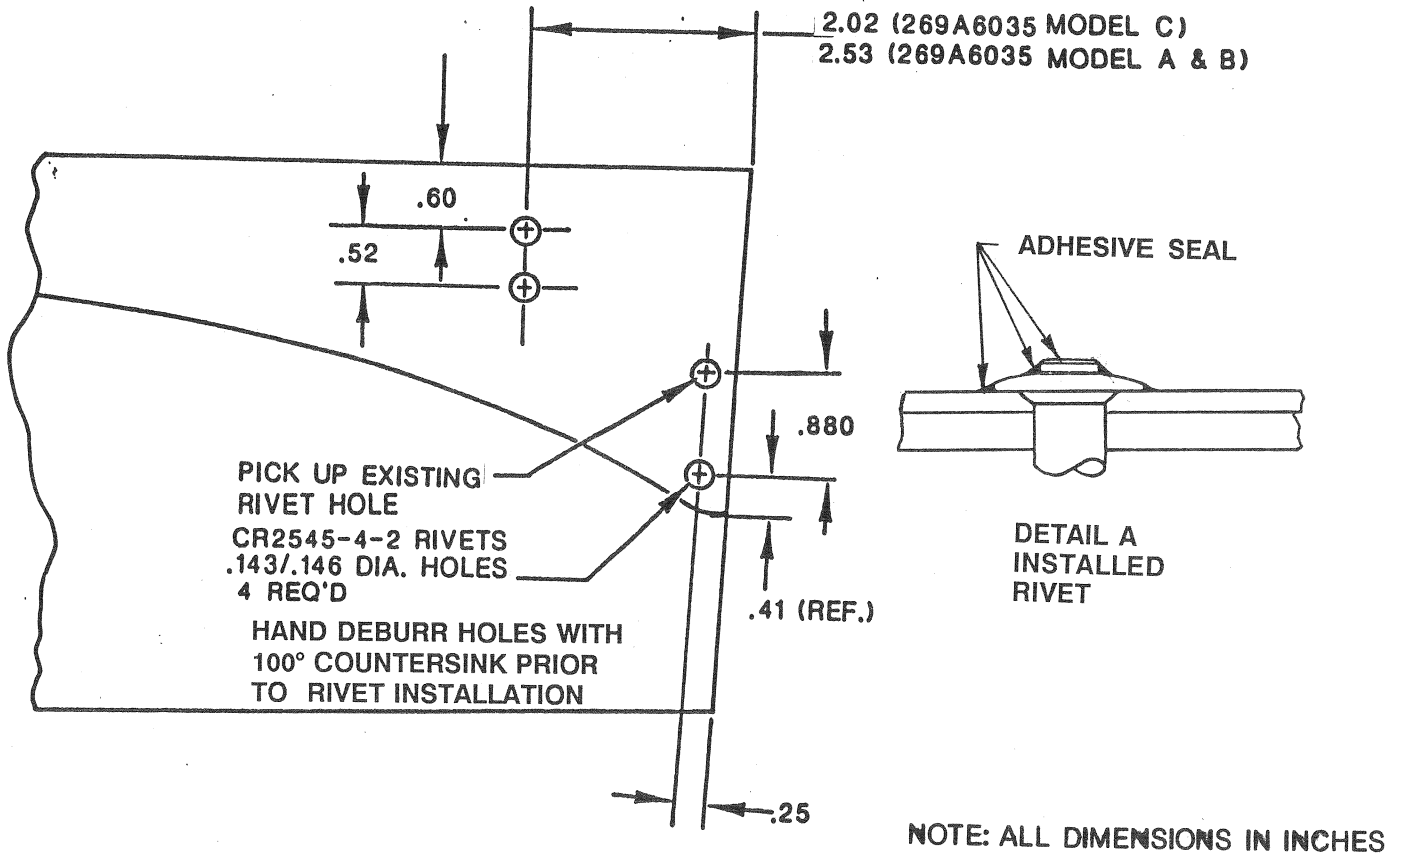
FIGURE 1. ABRASION STRIP RIVET HOLE LOCATION

Reports indicate that the affected tail rotor blades are subject to possible separation of abrasion strip from blade skin.

Part III of this notice provides instructions for mandatory installation of rivets in abrasion strip. This will prevent total separation of abrasion strip from tail rotor blade in the event of epoxy bond failure. Modified blades must be installed in sets of two.

IT IS IMPORTANT TO LOCATE RIVET HOLES EXACTLY AS SPECIFIED IN THE FOLLOWING. FAILURE TO DO SO MAY AFFECT STRUCTURAL INTEGRITY.

- IT IS IMPORTANT TO MAINTAIN ADEQUATE EDGE DISTANCE WHEN DRILLING THE TWO OUT-BOARD RIVET HOLES. LACK OF EDGE DISTANCE WILL WEAKEN THE MATERIAL AND MAY CAUSE CRACKING WHEN THE RIVETS ARE INSTALLED.
 - USE A DRILL STOP TO PREVENT DRILLING INTO OPPOSITE SIDE.
 - TO MAINTAIN PROPER HOLE SIZE AND SATISFACTORY RIVET INSTALLATION, IT IS IMPORTANT TO HAVE BLADE RESTING FLAT ON WORK SURFACE DURING DRILLING AND RIVETING OPERATIONS.
- c. Using a No. 27 Cobalt drill, locate and drill four rivet holes as shown on Figure 1.
- d. Hand deburr rivet holes using 100° countersink.
- e. Using epoxy adhesive, wet install four CR2545-4-2 rivets. (Allow adequate drying time prior to performing step h. below.)

- g. Remove defective rivet(s) as follows:
- (1) Carefully grind off locking collar and upper portion of rivet stem.
 - (2) Using a drill stop, drill through rivet stem using care to prevent hole enlargement.
 - (3) Push remaining rivet stem (with sheer ring) from hole, and remove from spar.
 - (4) Inspect hole in spar. If defective, consult SAC.
 - (5) Return to step d. above and install new rivet(s).
- h. Coat the exposed rivet heads with epoxy adhesive. Ensure that stems and rivet head edges are sealed, but do NOT apply excessive adhesive. (See Detail A, Figure 1.) Also ensure that adhesive is smooth without voids.
