HUGHES SERVICE INFORMATION NOTICE

NOTICE NO. N-19

DATE December 2, 1966

SUBJECT: FIELD MODIFICATION - INDUCTION SYSTEM AIR
FILTER HOUSING P/N 8143

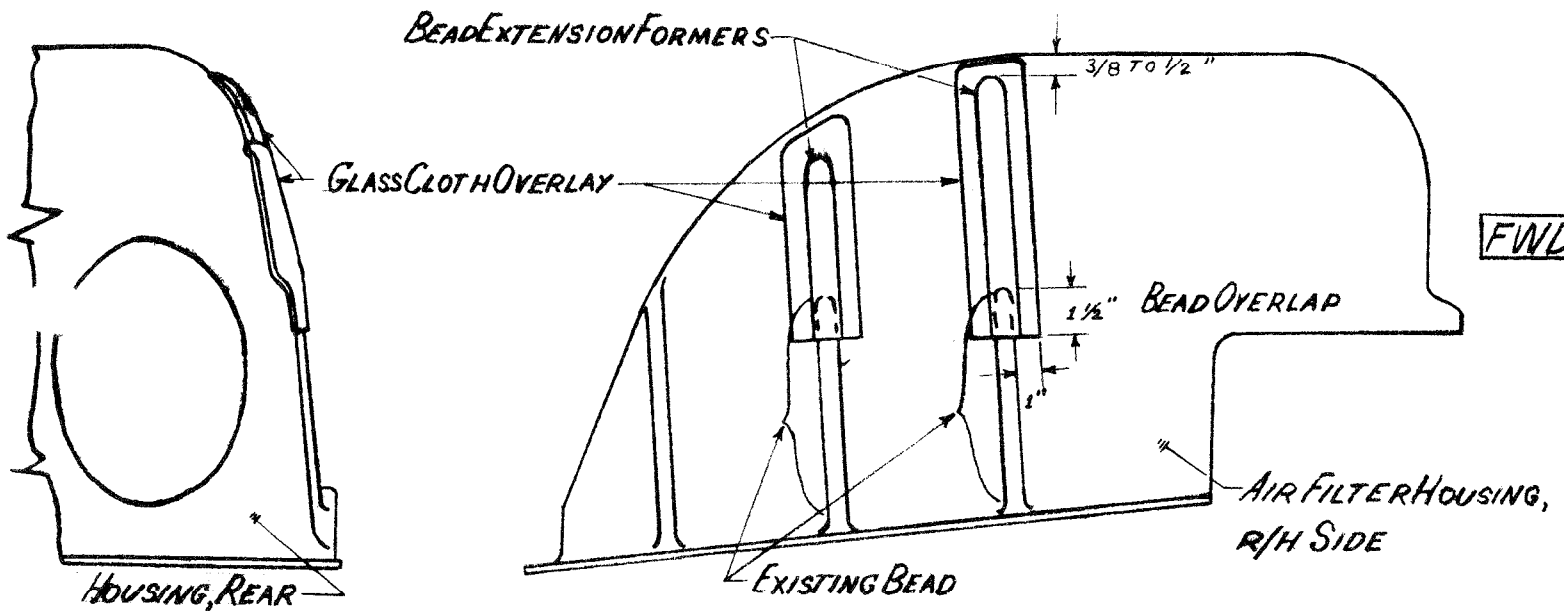
FIGURE 1.

PURPOSE: To provide additional stiffness to the right side of
the housing. The procedure defined in this notice
outlines the method of adding extensions to the
existing beads. The increased strength will help
prevent cracking of the housing.

- a. Remove lower forward fairing from rotorcraft.
- b. Using solvent, remove grease, dirt and other foreign material from right side of air filter housing.
- c. Make from balsa wood or rolled fiberglass cloth, two formers approximate size of existing beads, cut to proper length. (See Figure 1)
- d. Cut fiberglass cloth to provide at least 1 inch of contact with flat surface of housing on each side of bead. Cut strips of sufficient length to overlap top of existing bead at least 1 - 1/2 inches.
- e. Completed bead extensions shall extend up side of housing to within from 3/8 to 1/2 inch of top of housing.
- f. Position bead former on side of housing, secure with one strip of glass cloth (refer to step c) and resin.
- g. Remove wrinkles and bubbles fairing cloth to housing. Add second strip of cloth over first in same manner.
- h. Repeat step e. for remaining bead.

- i. Remove rough or jagged edges using emery paper (150 grit approx.)
- j. Inspect modification for security.
- k. Reinstall lower forward fairing.
