# SCHWEIZER SERVICE NOTICE

NOTICE NO. N-198

DATE: 28 FEB 86

SUBJECT: INSPECTION AND REWORK OF TAIL ROTOR PITCH CONTROL LINK ASSEMBLY, P/N 269A6091-5 and 369A1807-7

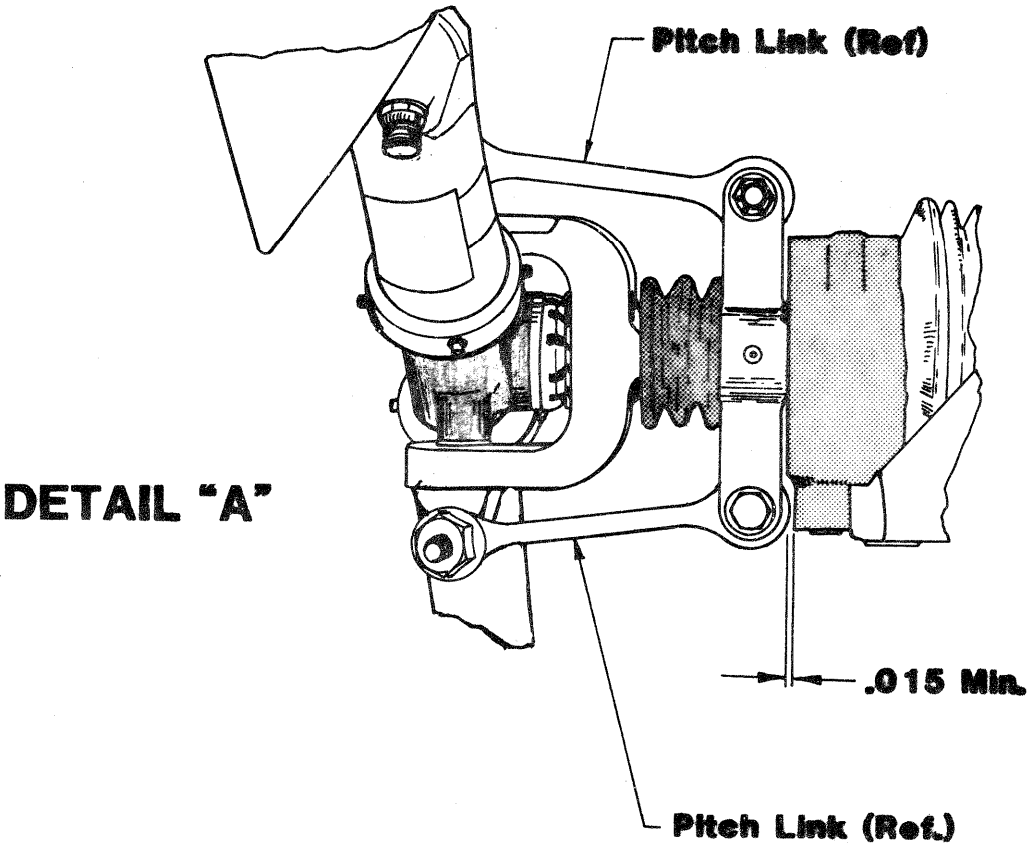
1. Refer to Detail "A". Rotate Tail Rotor Assembly to align pitch link with lower boss on pitch control housing. Swash-plate will now be vertical.
2. Using feeler gauges check the clearance between the end of the pitch link assembly and pitch control housing. A minimum of .015 inches must exist or pitch link must be reworked per paragraph 5.
3. Rotate tail rotor 180° and check second pitch link assembly for proper clearance as stated in Paragraph 2.
4. Remove pitch links and reverse (switch end for end), reinstall and reinspect per paragraphs 1 thru 3. Refer to Basic HMI,

5. If both links are shown to provide adequate clearance then no further inspection or rework is required.
6. If adequate clearance is not found, remove pitch link or links per Basic HMI Section 9, Paragraph 9.

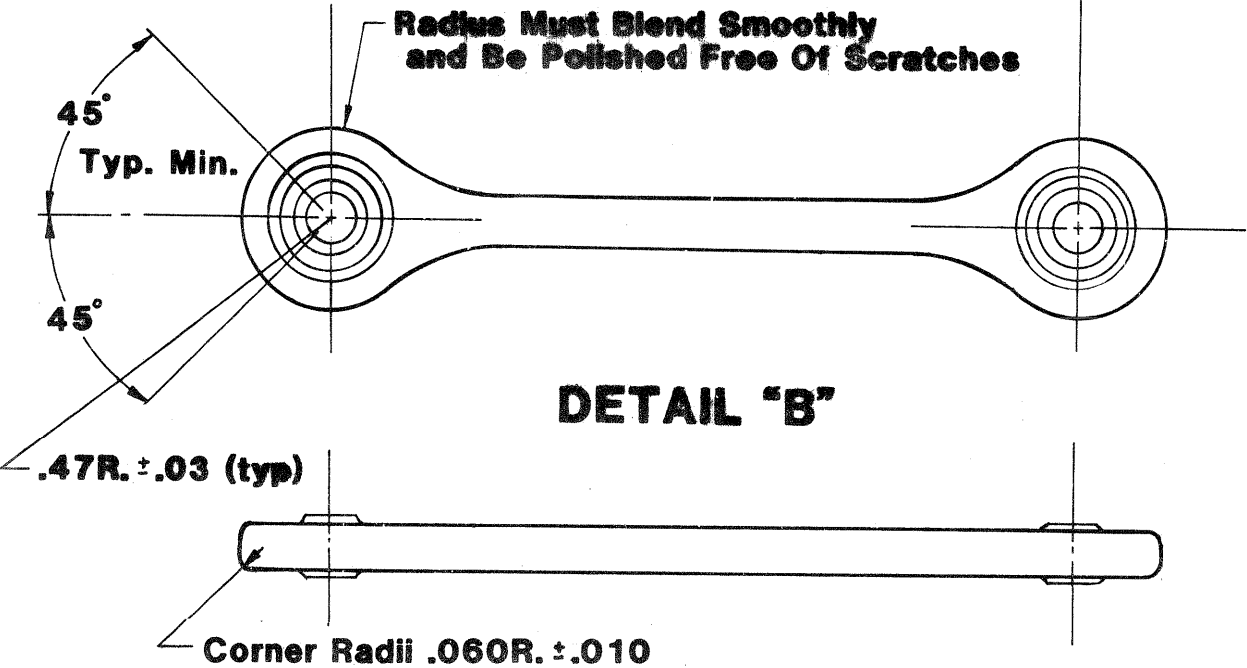
- b. Inspect pitch link dimensions per Detail "B" for proper edge distance from center of bearing hole to edge of forging. This dimension is to be .47 radius  $\pm$  .03, including flashing area for a min. of 45° from center line, both ends. Links found to be in excess of this dimension may be disk-sanded to bring the dimension within tolerance. All sanding must blend smoothly with the radius contour of the link. All sanding must be polished to a smooth finish with 600 grit paper to remove all scratches.

- c. Touch up reworked areas with alodine, primer and paint per Basic HMI, Section 2-53 or equivalent.
- d. Reinstall pitch link per Basic HMI, Section 9, Paragraph 9.
