# SCHWEIZER SERVICE NOTICE

NOTICE NO. N-203

SUBJECT: VISUAL CHECK TO ENSURE THAT PROPER THRUST BEARING TUBE IS INSTALLED

MODELS AFFECTED: All 269 Series helicopters.

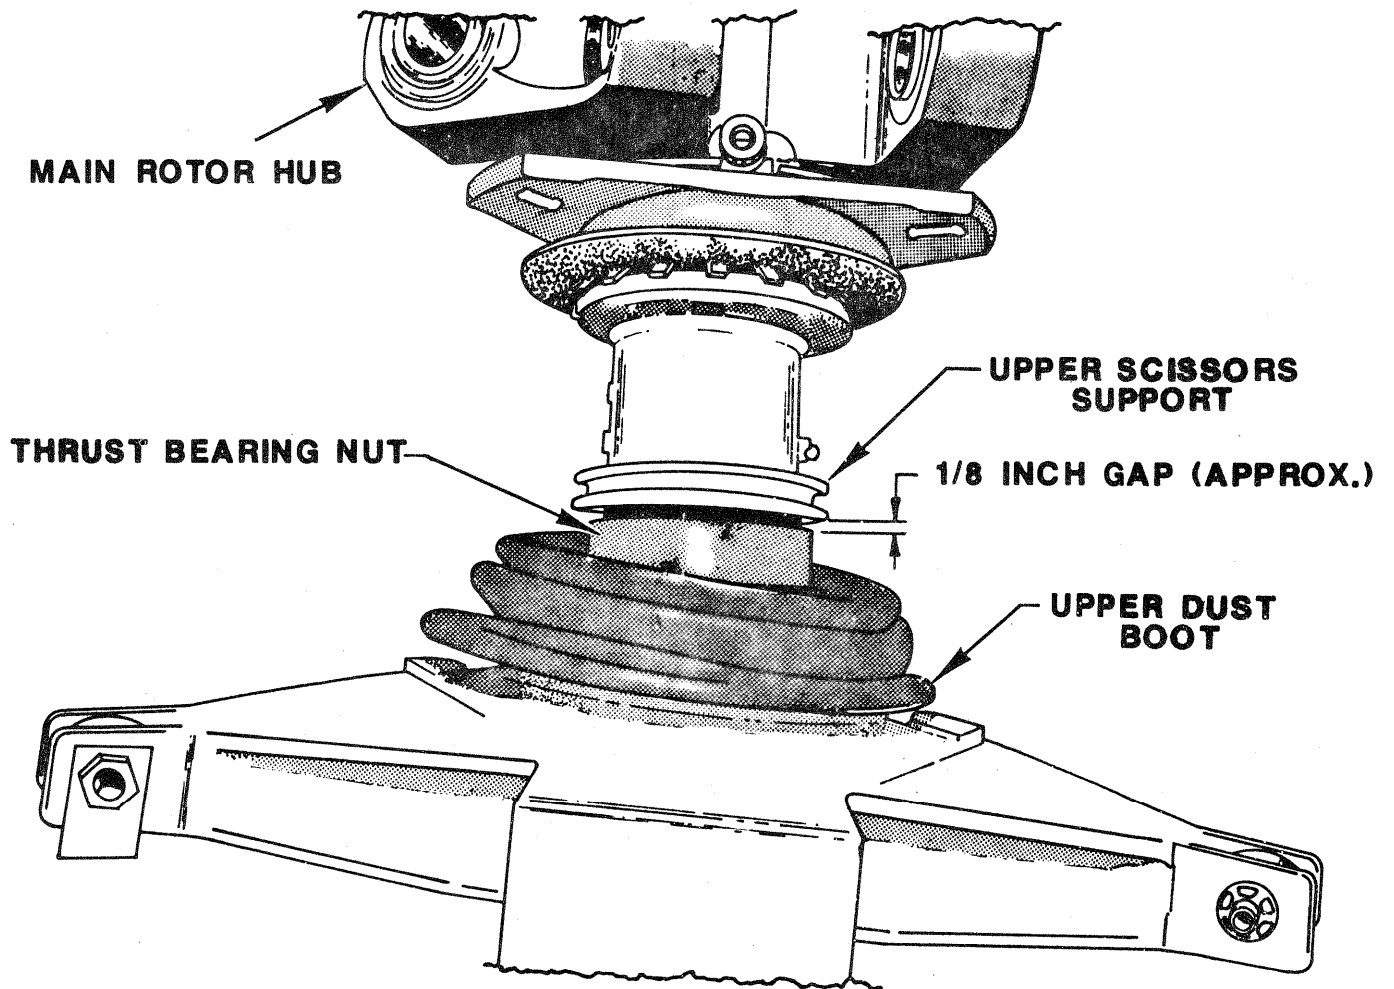
FIGURE 1.

PREFACE: Field reports indicate that improper thrust bearing tubes have been installed during the installation of main rotor drive shaft and thrust bearing (Basic HMI, Section 10). The information provided in this Service Information Notice lists instructions to check for a gap between the thrust bearing nut and scissors support. A gap between these parts is substantial evidence to conclude that the proper tube was installed.

- a. Following installation of main rotor hub assembly (Basic HMI, Section 8), check for a gap between thrust bearing nut and scissors support as follows:
  - (1) Slide upper dust boot off from scissors support.
  - (2) Force boot downward to gain visual access.
  - (3) Determine that a gap (approximately 1/8 inch) exists between thrust bearing nut and scissors support. (See Figure 1.)

- b. If no gap exists, remove thrust bearing tube as follows:
- (1) Remove main rotor hub and swashplate assembly (Basic HMI, Section 8).
  - (2) Bend eight tangs on thrust bearing nut lockwasher to clear thrust bearing nut and mast assembly.
  - (3) Remove thrust bearing nut using bearing nut wrench and a 30-inch extension arm.
  - (4) Remove thrust bearing tube.
  - (5) Check part number of thrust bearing tube against those listed in 269 Series IPC.
  - (6) Reinstall main rotor components using proper thrust bearing tube. (Refer to HMI Temporary Revision No. R-3.)
- c. Reinstall upper dust boot.
