SCHWEIZER SERVICE NOTICE

NOTICE NO. N-204

SUBJECT: IDENTIFICATION AND POSSIBLE REPLACEMENT OF COLLECTIVE PITCH MIXER BELLCRANK.

MODELS AFFECTED: ● All Model 269A, 269(TH-55A), 269A-1, 269B Helicopters.
● All Model 269C Helicopters having a serial number prior to 1274.
● All 269A7522 Collective Pitch Mixer Bellcranks in spares inventory.

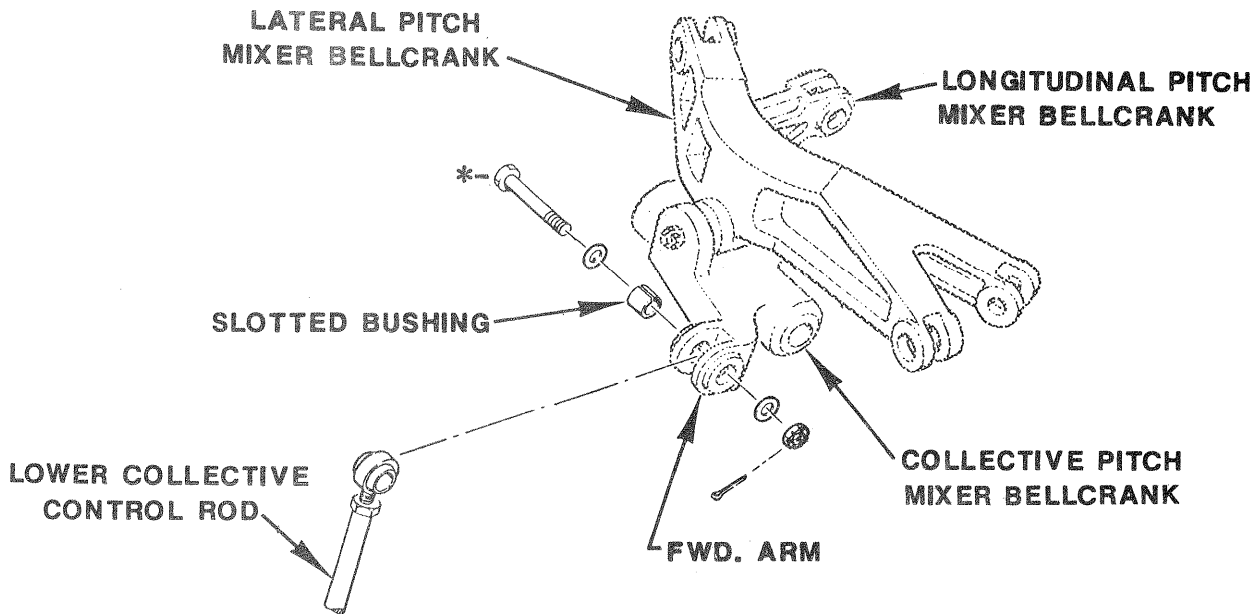
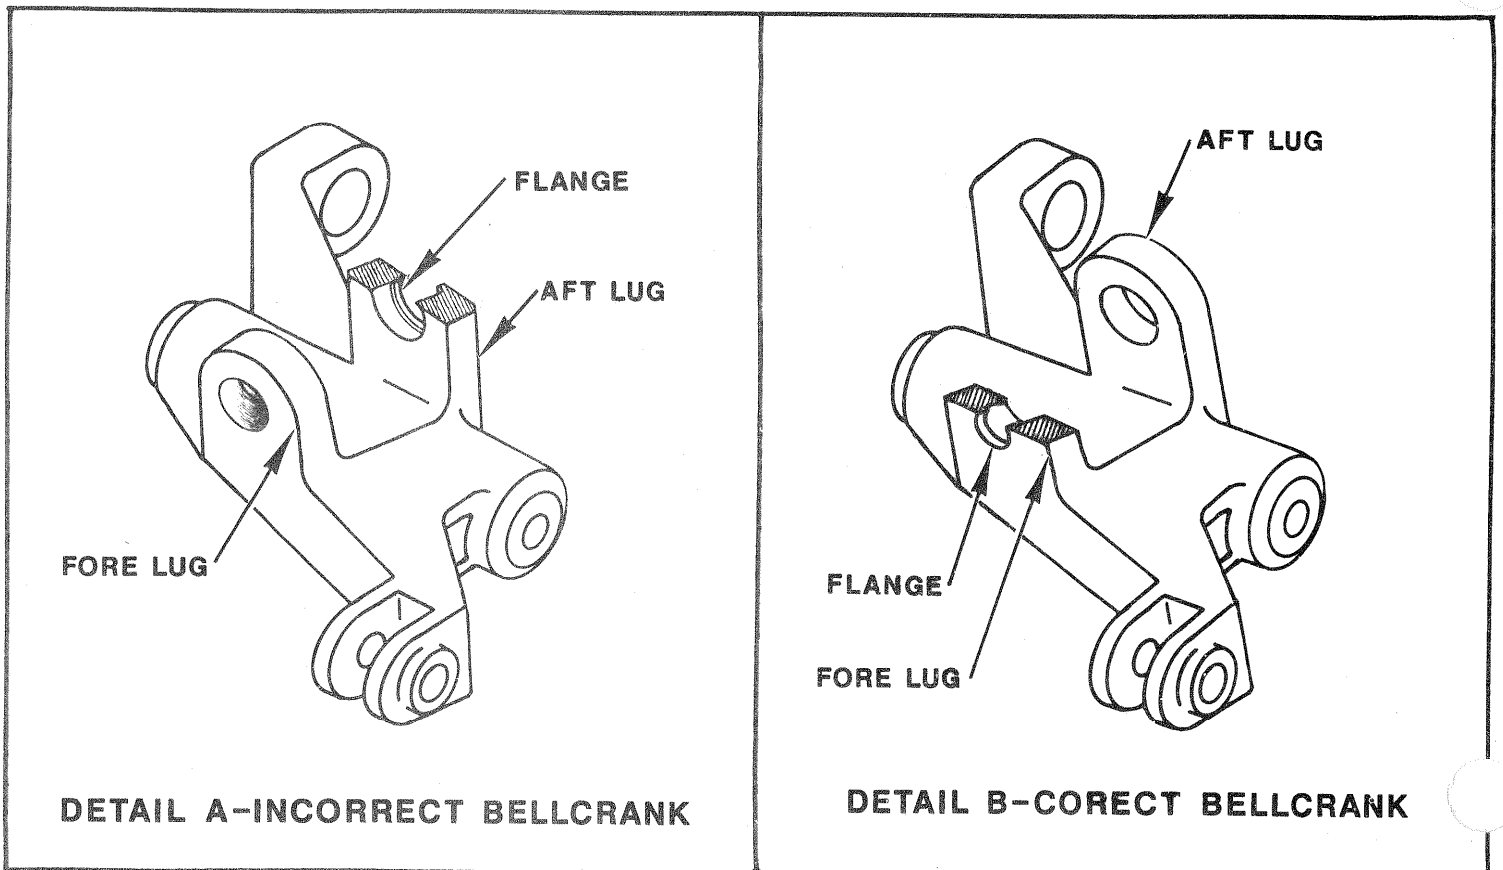
FIGURE 1. COLLECTIVE PITCH MIXER BELLCRANK

PREFACE: A possibility exists that some 269 Series Helicopters may be equipped with an incorrect collective pitch mixer bellcrank. The incorrect bellcrank incorporates a flange on the aft lug bearing bore ID (Figure 1, Detail A). The correct bellcrank possesses the flange on the fore lug bearing bore ID (Figure 1, Detail B). In addition to this flange (on the fore lug bearing bore ID), the collective pitch mixer bellcrank should incorporate a rounded edge (.12 inch radius) on the lower right-hand edge of the bellcrank aft arm (Figure 3). Bellcranks which do not incorporate this rounded edge may cause damage to the bellcrank support mast lug if the aft arm is allowed to swing down and hit the lug (when the controls are disconnected).

The incorrect collective pitch mixer bellcrank incorporates a flange on the aft lug bearing bore ID (Figure 1, Detail A). The correct bellcrank possesses the flange on the fore lug bearing bore ID (Figure 1, Detail B).

*-ATTACHES LOWER COLLECTIVE CONTROL ROD TO COLLECTIVE PITCH MIXER BELLCRANK

- (2) Using a correct collective pitch mixer bellcrank (Figure 1, Detail B), reassemble components in accordance with Basic HMI, paragraph 8-109.
- e. Check the lower right-hand edge of the bellcrank aft arm (for a rounded corner) as follows:
- (1) If installed, remove right-hand side fuel tank in accordance with Basic HMI, Section 5 to gain access to bellcrank aft arm.
 - (2) Check the lower right-hand edge of the bellcrank aft arm for a round corner. (Refer to Figure 3.)

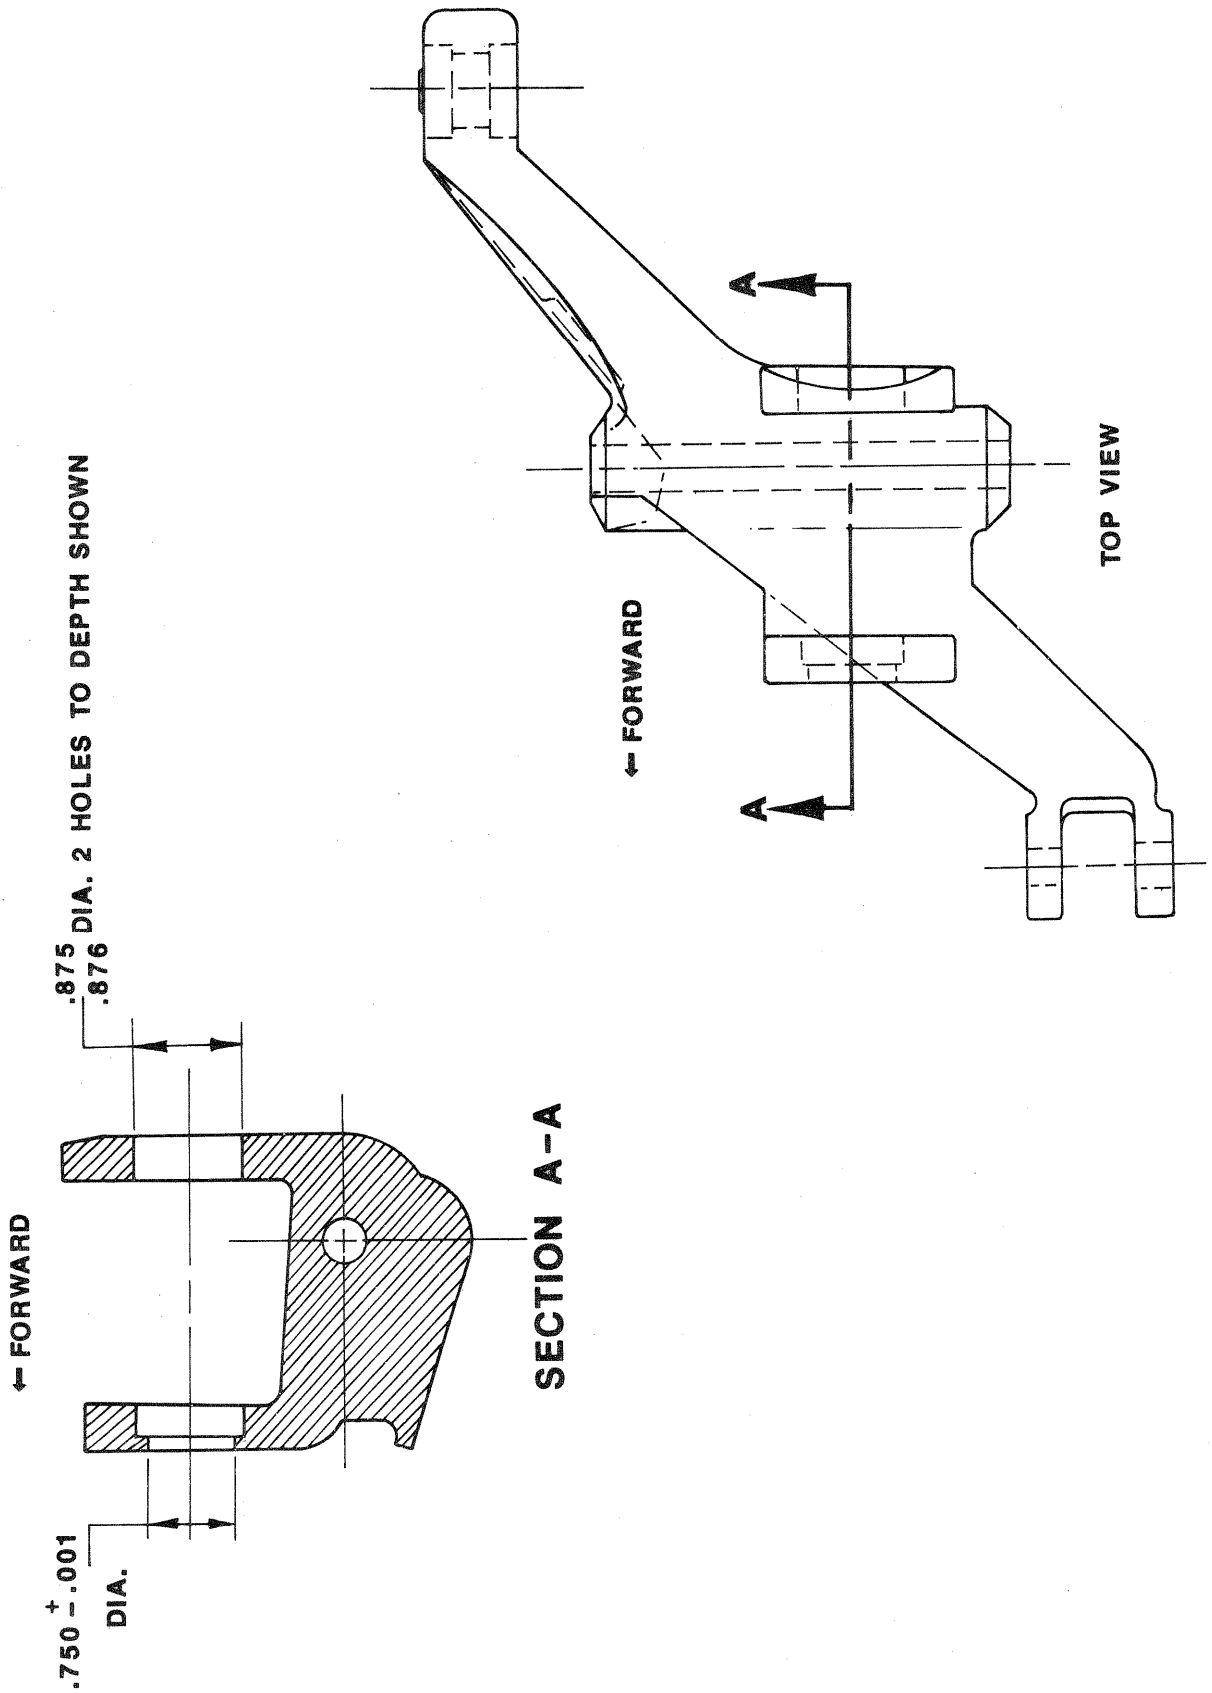
FIGURE 2. COLLECTIVE PITCH MIXER BELLCRANK
DIMENSIONAL REQUIREMENTS

- (1) Using a suitable measuring device, determine the ID at the aft edge of the aft lug bearing bore and the ID at the fwd edge of the fore lug bearing bore. (Refer to Figure 2, Section A-A for measurement locations and requirements.)
- (2) Remove from stock all 269A7522 bellcranks which do not meet the dimensional requirements of Figure 2, Section A-A. (Contact your SAC Customer Service Center or Distributor for disposition of incorrect bellcranks.)

- (4) If the dimension measured in the previous step is not within the required limits (0.750 \pm 0.001-inch), remove and replace the bellcrank (PN 269A7522) in accordance with step d below.

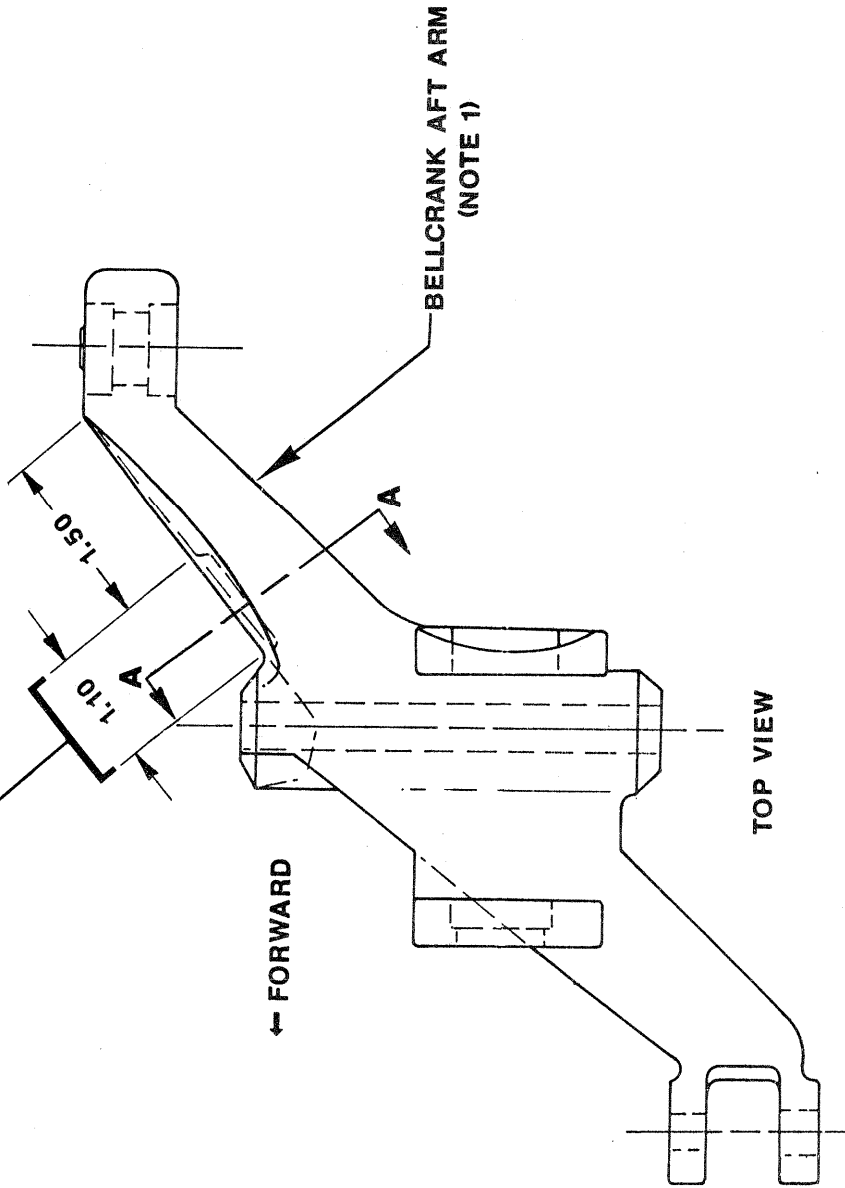
FIGURE 3. COLLECTIVE PITCH MIXER BELLCRANK

If the lower right-hand edge of the bellcrank aft arm is not round, it is possible (when control rods are disconnected) for the bellcrank aft arm to swing down and nick the bellcrank support mast lug. Bellcranks that do not possess a rounded corner at the lower right-hand edge of the aft arm, must be modified in accordance with step e.

NOTE 1. CHECK THAT LOWER R.H. EDGE OF
BELLCRANK ARM IS ROUND. IF EDGE IS
NOT ROUND, USE FILE TO INSTALL A
.12 INCH RADIUS (APPROX.).

.12 R FOR 1.10 LENGTH
(APPROX.)

EDGE MUST BE ROUNDED
IN THIS AREA.

- (3) If lower right-hand edge is not round, use progressively finer grades of abrasive materials to make edge round. (Refer to Figure 3.) Polish smooth with abrasive paper, not coarser than 360 grit.

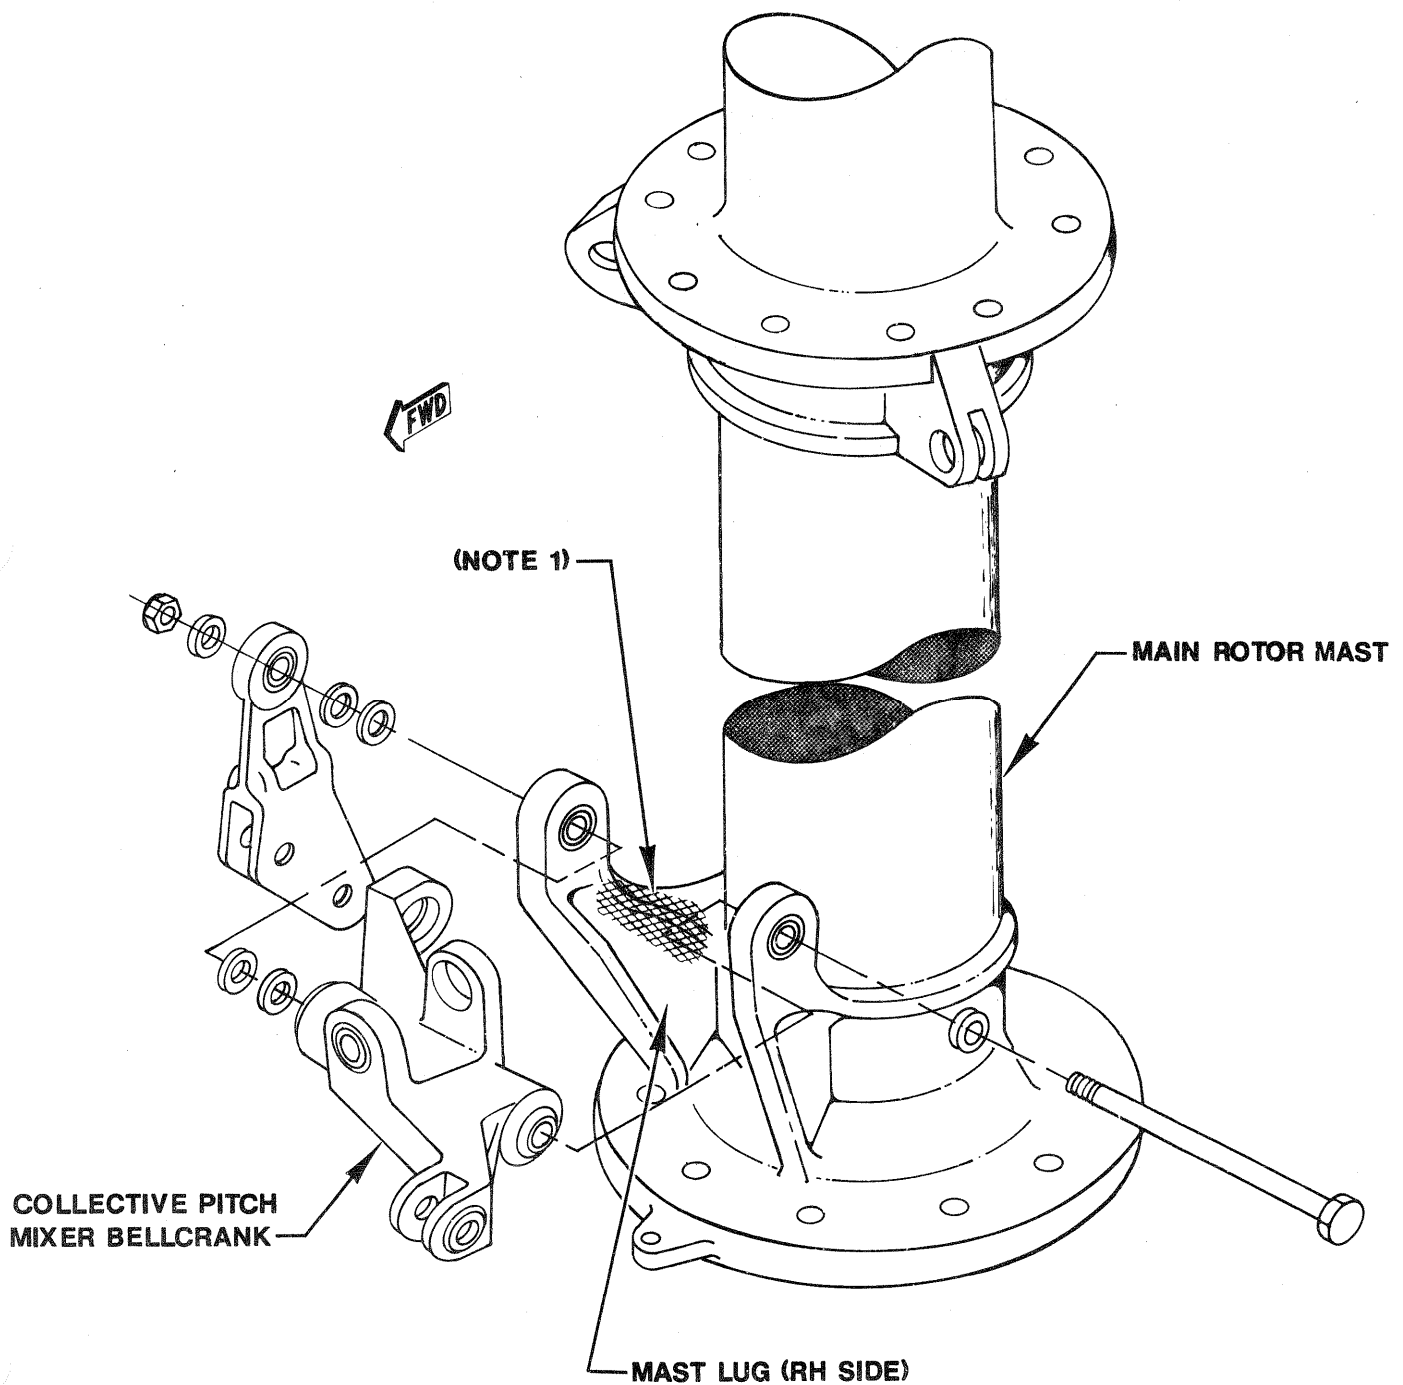
FIGURE 4. DYE-PENETRANT INSPECTION OF MAST LUG

- (4) Check right mast lug for nicks (caused by bellcrank). (Refer to Figure 4.)
 - (5) If any nicks are found in mast lug, feather out nicks with a fine file. Polish smooth with abrasive paper.

**NOTE 1. DYE-PENETRANT INSPECT
SHADED AREA FOR CRACKS.**

- (6) If nicks are found, strip paint and dye-penetrant inspect mast lugs for cracks in accordance with Basic HMI, Section 13. If cracks are found, replace mast. If mast is still serviceable, treat lug with Dow #19 and repaint in accordance with Basic HMI, Section 2.
