# SCHWEIZER SERVICE NOTICE

NOTICE NO. N-208

SUBJECT: IDENTIFICATION AND POSSIBLE REPLACEMENT OF TAIL ROTOR FORK BOLT.

- All 269 Series Helicopters equipped with a 269A6034 tail rotor assembly.
- All 269A6034 tail rotor assemblies in spares inventory.
- All 369A1602 tail rotor fork bolts in spares inventory.

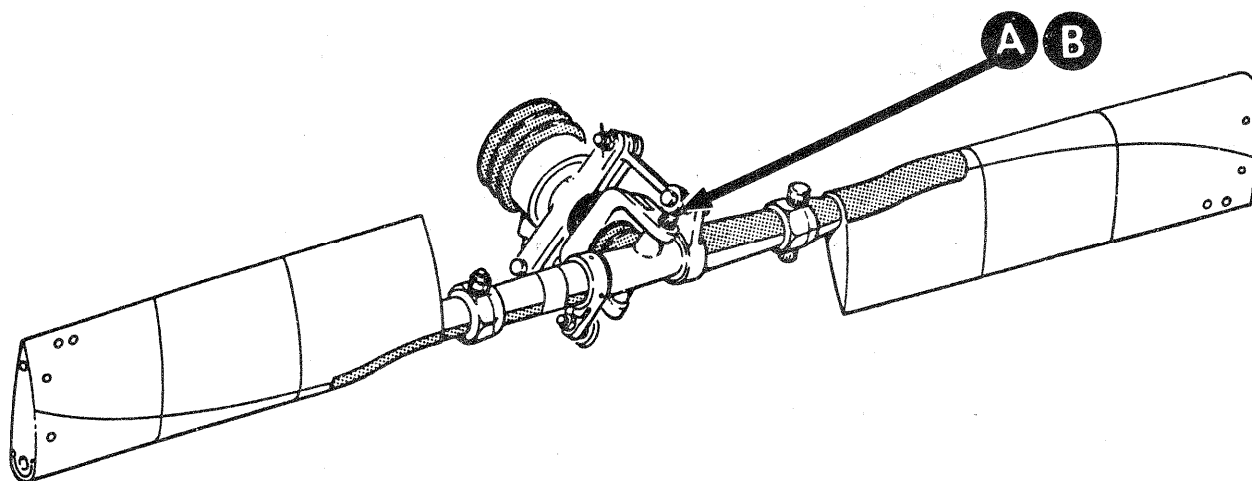
**TAIL ROTOR ASSEMBLY**

- a. Visually examine the inscription on the tail rotor fork bolt (Figure 1).

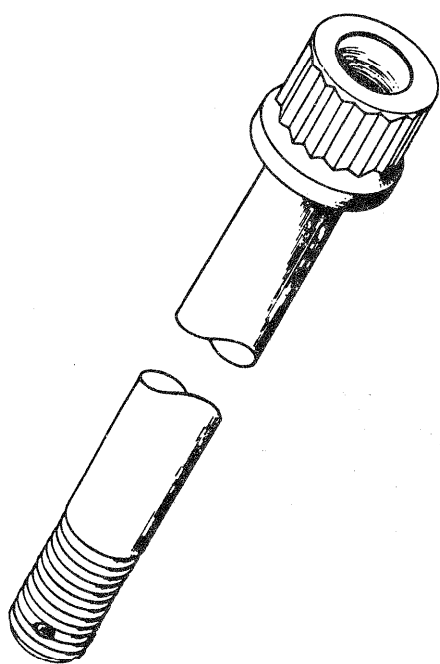
**DETAIL A. SUSPECT BOLT**

PREFACE: A possibility exists that the 369A1602 tail rotor fork bolts, manufactured between April 18, 1986 and August 28, 1986, did not receive proper processing at the manufacturer. Incomplete processing of these bolts can result in cracking and eventual bolt failure. This Service Information Notice provides instructions to identify and replace (as required) the suspect bolt. Compliance with this Service Information Notice is essential to ensure the continued airworthiness of all 269 Series Helicopters.

Some 369A1602 tail rotor fork bolts manufactured in 1986 received incomplete processing. These bolts lack the inscription on the head (Figure 1, Detail B). However, since some properly processed fork bolts (369A1602) were manufactured without the inscription (prior to 1975), we cannot conclude that all uninscribed bolts were improperly processed. All uninscribed bolts manufactured in the year 1986 must be removed from service and stock. Uninscribed bolts whose manufacture date cannot be positively determined to be prior to 1986, must also be removed from service and stock.

- c. Check stock and remove all improperly processed bolts. (Contact your Schweizer Service Center or Distributor for disposition of bolts.)
- d. Remove improperly processed bolts from tail rotor assembly as follows:

- (1) If installed, remove tail rotor assembly (Basic HMI, Section 9). (Removal of pitch control assembly is not required.)
- (2) Disassemble tail rotor assembly into major assemblies (HMI Appendix C, Part VII, paragraph 2-3).
- (3) Remove fork bolt by following applicable instructions in HMI Appendix C, Part VII, paragraph 2-4.
- (4) Using a new fork bolt, reassemble hub and fork unit in accordance with HMI Appendix C, Part VII, Section 6 and Service Information Notice N-155.2.
- (5) Reinstall tail rotor assembly (Basic HMI, Section 9).
- (6) Perform testing and balancing procedures per HMI Appendix C, Part VII, Section 7.

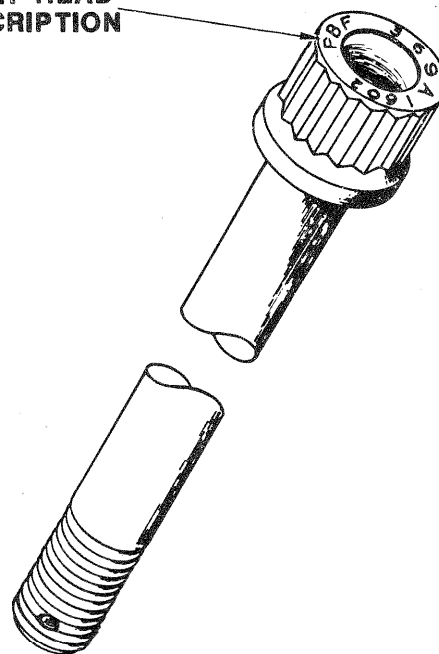
**DETAIL B. CORRECTLY  
PROCESSED BOLT**

The head of properly processed bolts are inscribed as shown in Figure 1, Detail B. If the helicopter is equipped with an inscribed bolt (Figure 1, Detail B), further inspection and disassembly is not required. Record compliance with this Service Information Notice in Compliance Section of Helicopter Log Book, if the fork bolt is inscribed (Figure 1, Detail B).

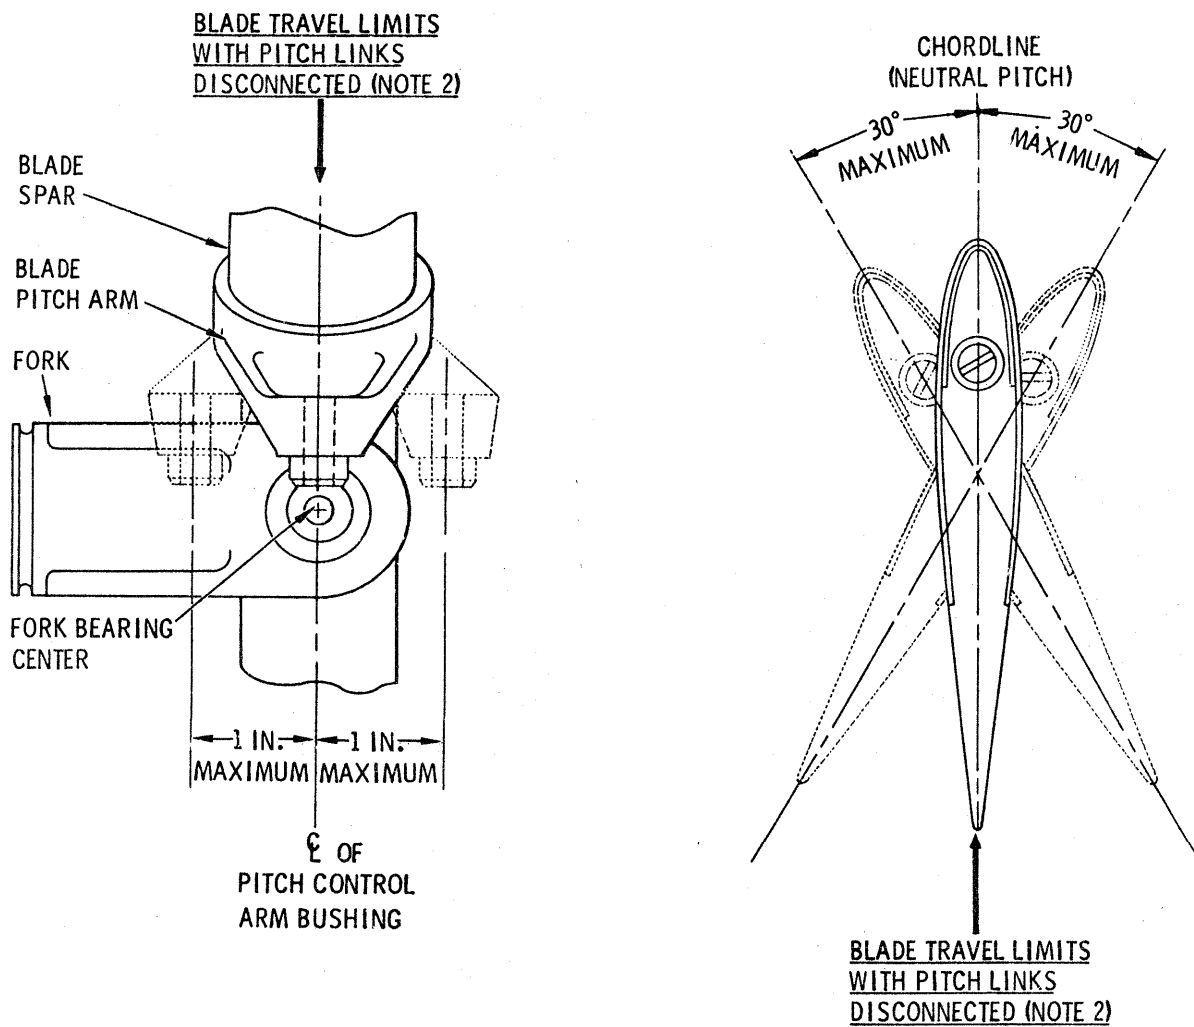
**FIGURE 2.**

When the blade and hub assembly is removed from the helicopter, and at all times when the pitch control links are disconnected, do not allow blade pitch angle to exceed 30 degrees from the neutral position. (See Figure 2.) Unrestricted rotation of blades on the hub can excessively bend or stretch the internal tension-torsion strap assembly and cause undetected damage to the strap assembly, and an out-of-balance condition for the tail rotor.

**NOTE 2. CAUTION:** DO NOT ALLOW BLADE PITCH TRAVEL TO EXCEED LIMITS SHOWN. ROTATING THE BLADES TO EXCESSIVE PITCH ANGLES MAY RESULT IN UNDETECTED DAMAGE TO TENSION-TORSION STRAP ASSY.
