SCHWEIZER SERVICE NOTICE

NOTICE NO. N-209

SUBJECT: ONE TIME INSPECTION OF BELT DRIVE UPPER PULLEY ASSEMBLY.

MODELS AFFECTED: All Model 269C Helicopters having a serial number of 1166 to 1259.

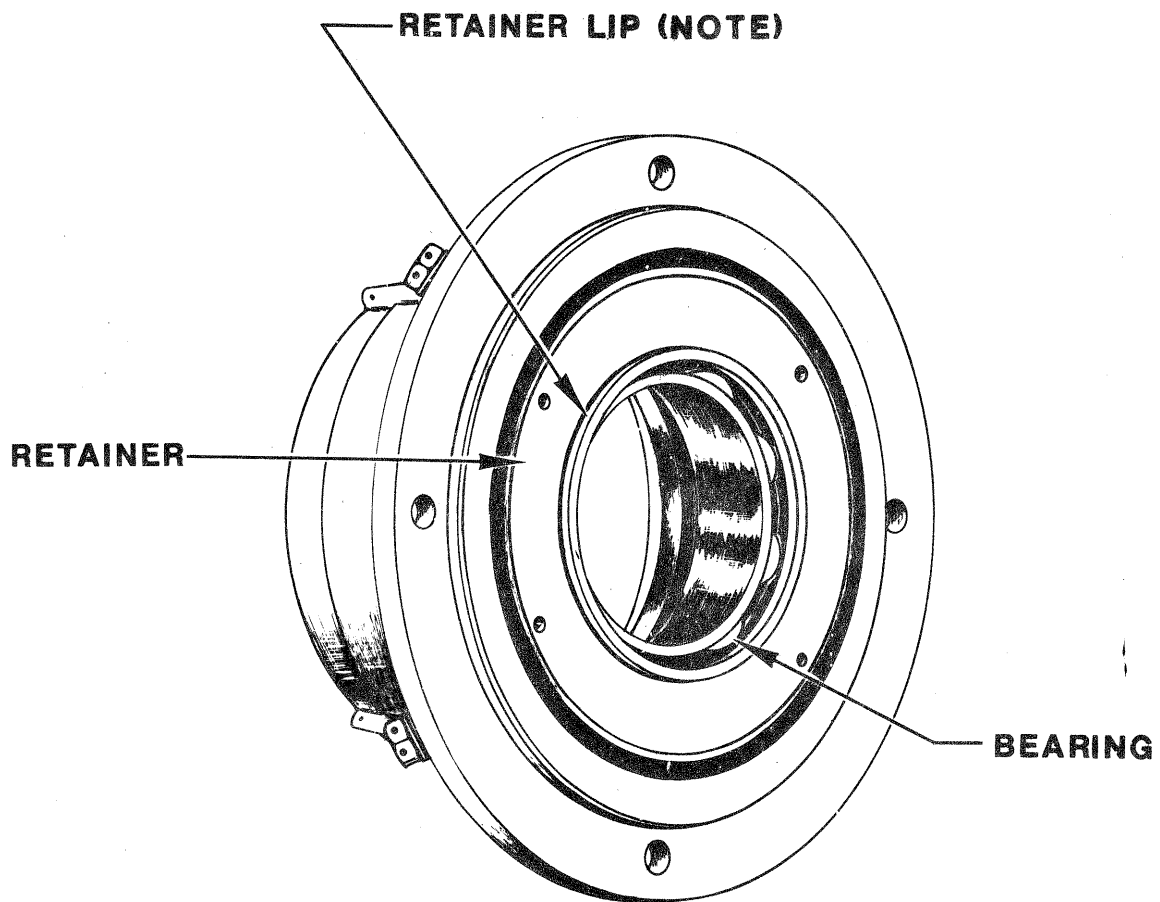
FIGURE 1. UPPER PULLEY END CAP

PREFACE: A possibility exists that the forward and aft end caps installed on the affected upper pulley assemblies (those installed on the affected helicopters) may be equipped with retainers (FWD and AFT) which were installed backwards. This condition could lead to an inadequate oil supply to the upper pulley bearings, which may cause the bearings to wear out prematurely. This Service Information Notice lists instructions to remove, disassemble, and check the upper pulley assembly. Upper pulley caps which have the retainers installed backwards, must be disassembled and inspected as specified in the below procedure.

The retainers installed in the pulley end caps should be positioned so that the retainer lip is away from bearing (Figure 1). Some retainers may have been incorrectly installed in such a manner that the lip is in towards the bearing.

**NOTE: ENSURE THAT RETAINER LIP FACES OUTWARD,
AWAY FROM BEARING.**

- (2) Check position of retainer in cap. (Refer to Figure 1.)
- d. If retainers are incorrectly installed, proceed as follows:
 - (1) Press bearings from caps. (Retainers are pressed out with bearing.)
 - (2) Inspect bearings for evidence of looseness, wear, roughness, corrosion, brinelling, skewing, and cracks. Replace bearing if any damage is found.
