SCHWEIZER SERVICE NOTICE

NOTICE NO. N-212

DATE: 10 March 1988

SUBJECT: ONE-TIME X-RAY INSPECTION OF TAIL ROTOR BLADE SPAR (PN 269A6035-21 AND -23).

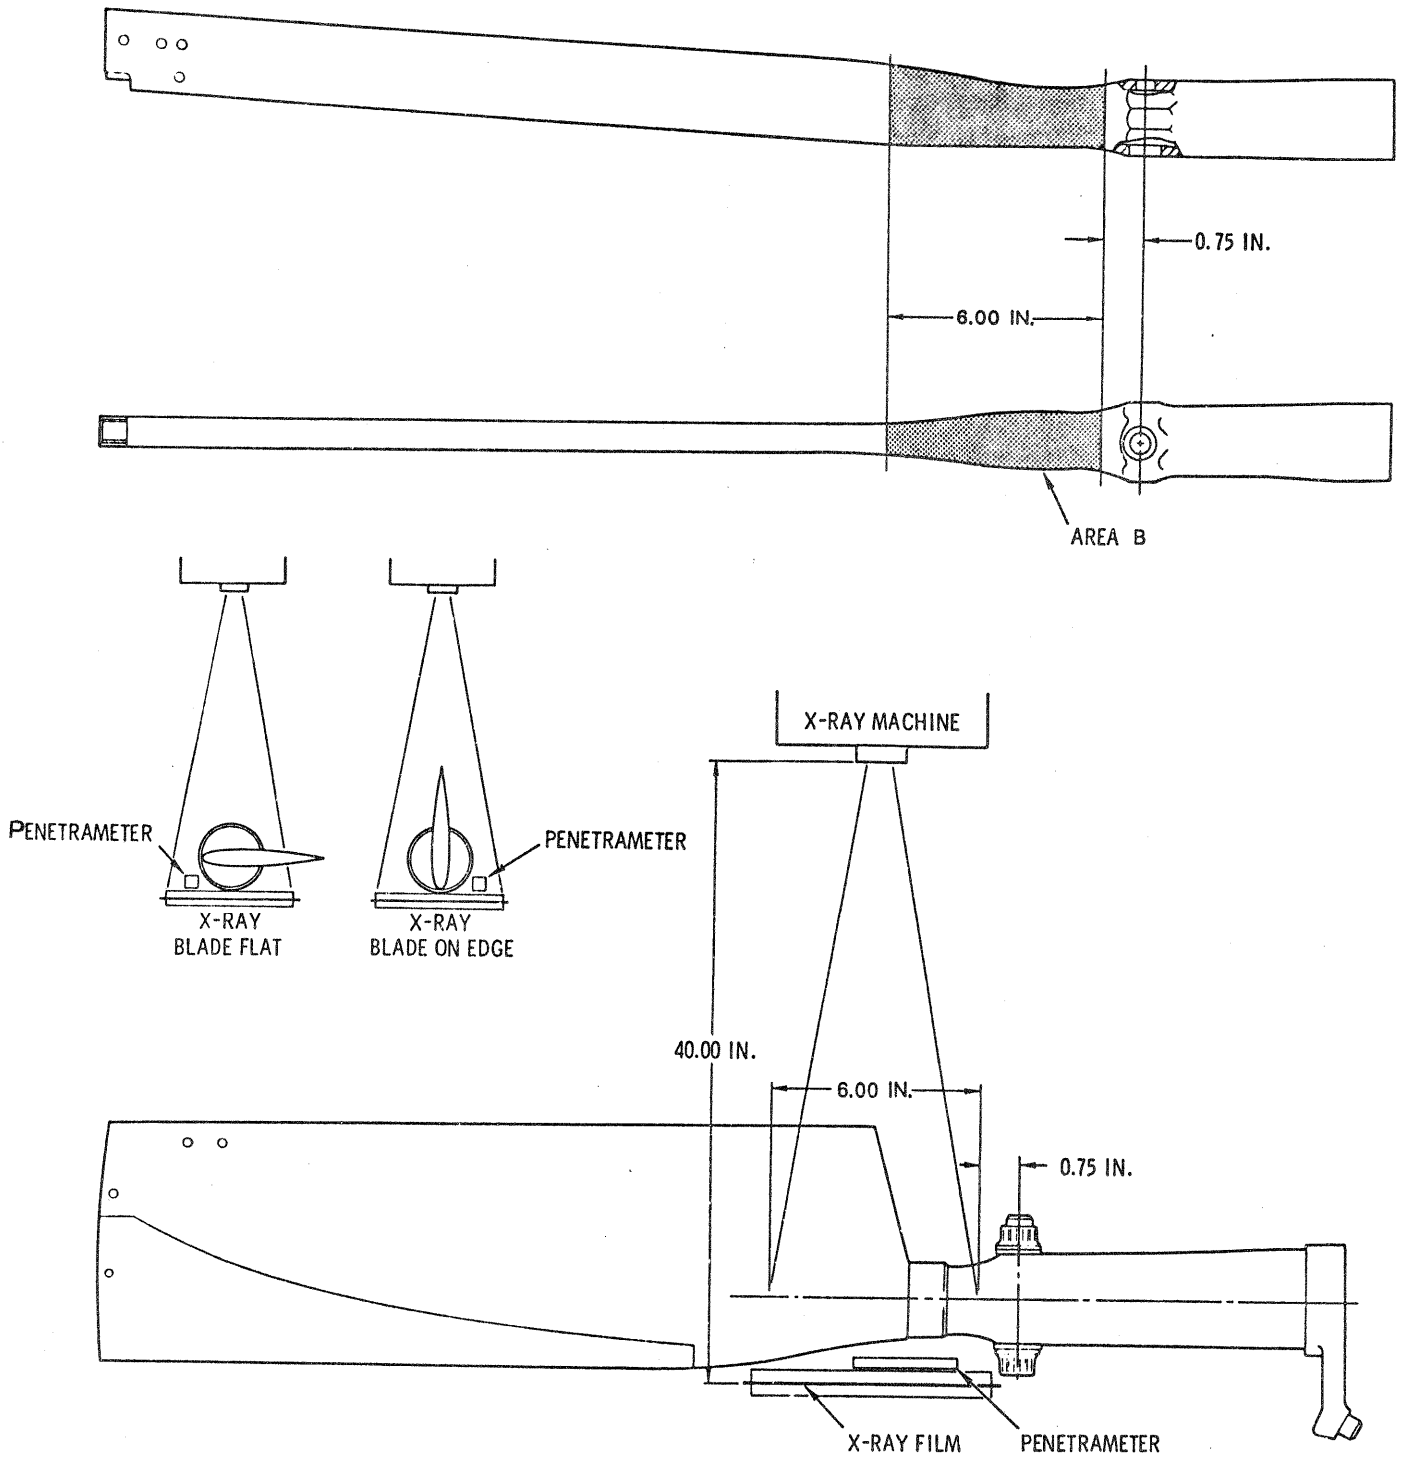
FIGURE 1. X-RAY INSPECTION OF TAIL ROTOR BLADE SPAR

PREFACE: Recent x-ray inspections of the affected tail rotor blade spars have revealed corrosive pits that were not evident during the periodic visual inspections for corrosion, required by HMI Appendix B. Engineering analysis of this situation has allowed SAC to determine that this pitting was caused by corrosion which occurred prior to the cadmium plate process on the blade spar.

IN ALL CASES WHERE THE BLADE'S X-RAY INSPECTION REVEALS INDICATION(S) OF PITTING IN THE INSPECTION AREA (FIGURE 1, AREA B), MAKE A COMPARISON BETWEEN THE X-RAY PATTERN AND THE INTERIOR PATTERN. IF PATTERNS DO NOT MATCH EXACTLY, THE BLADE MUST BE RETIRED FROM SERVICE BECAUSE IT INDICATES EXTERNAL CORROSION.

As specified in HMI Appendix C, Part VII the maximum allowable pitting on the interior surface of the spar is 0.006 in. deep x 0.015 in. wide x 0.020 in. long. Tail rotor blades whose spars have internal pits which exceed these limits must be removed from service.

- a. Perform preliminary procedure (HMI Appendix C, Part VII, para. 3-9).
- b. Perform periodic visual inspection of tail rotor blade spar (HMI Appendix C, Part VII, para. 3-10). Be sure to remove all loose scale and corrosion as specified in paragraph 3-10.
- c. X-ray each affected tail rotor blade in area from 0.75 inch to 6.75 inches outboard of blade retention bolt centerline (AREA B) as shown in Figure 1. Take x-rays in accordance with the referenced HMI Appendix C, Part VII, Paragraph 3-12.
- d. If any indication of pitting is visible in x-ray, inspect spar interior with a borescope to verify that all pits are on the interior surface of the blade spar.

- e. If external corrosion is found, retire blade from service prior to next flight. Conspicuously tag or mark blade to prevent inadvertent return to service.

- f. If spar is free of external corrosion in Area B, perform casting procedure to determine depth of corrosion pits. (Refer to HMI Appendix C, Part VII, Paragraph 3-11.)

- g. If pits exceed the limits, remove and retire blade from service.
- h. If blade is determined to be serviceable, proceed as follows:
- (1) If corrosion was found on the interior surface of the blade spar during the visual inspection (step b, above), treat and protect spar (to inhibit future corrosion) in accordance with HMI Appendix C, Part VII, paragraphs 3-13 and 3-14 (or 3-15).
