# SCHWEIZER SERVICE NOTICE

NOTICE NO. N-215  
DATE: SEPT 21, 1988  
PAGE: 1 of 5 pages

SUBJECT: Update of Model 269B and 269C Pilot's Flight Manual; Installation of 269A9928-5 and 269A9928-7 Center Cover Support Bracket.

MODELS AFFECTED: All Model 269B and 269C Helicopters.

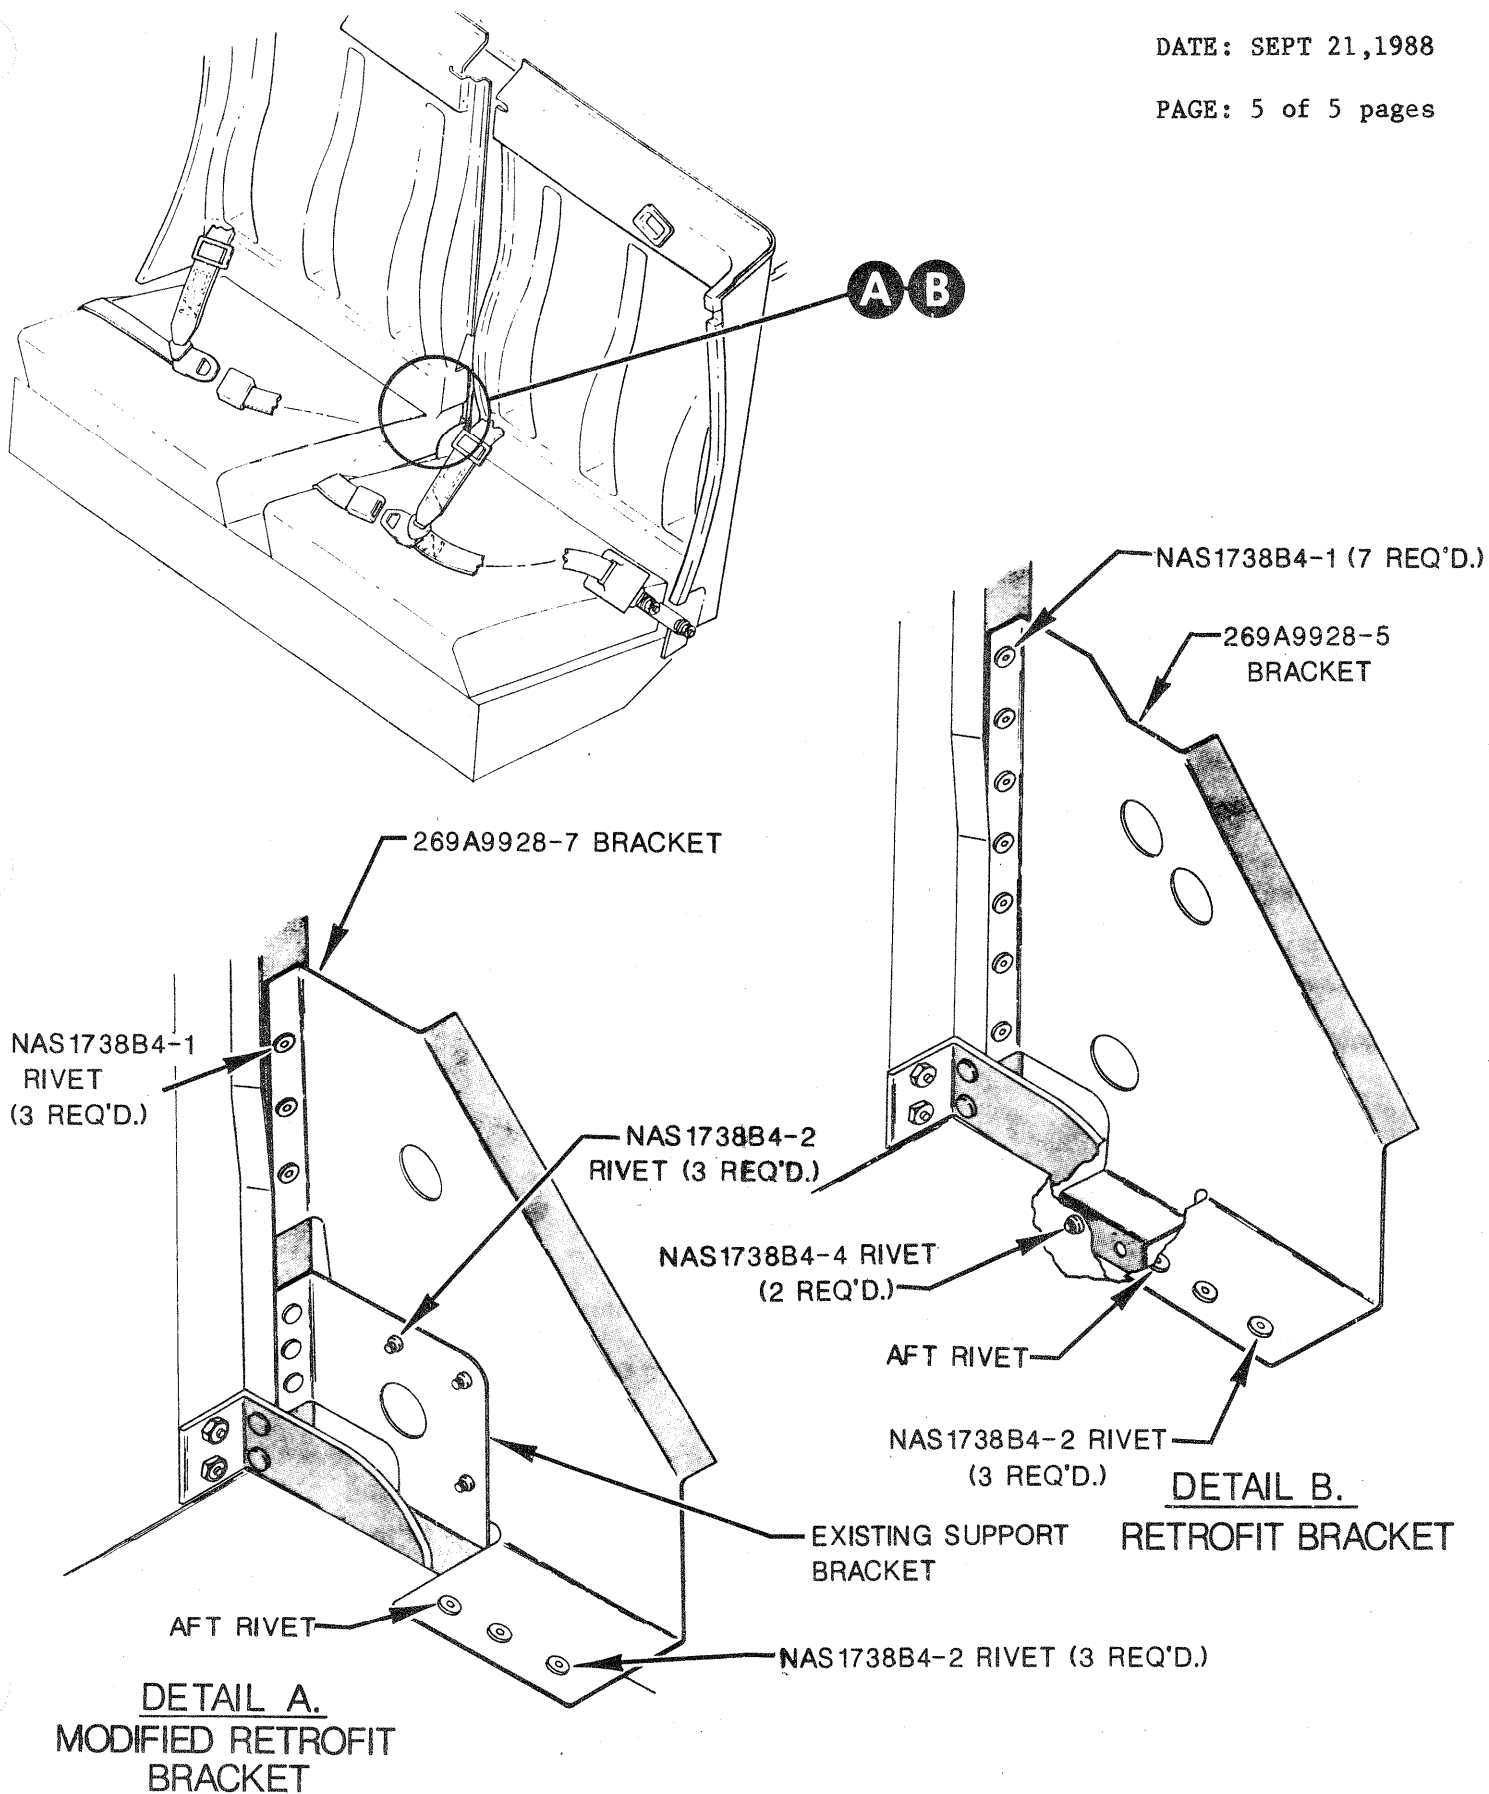
FIGURE 1. CENTER COVER SUPPORT BRACKET

PREFACE: Field reports indicate that the stowage of equipment between the center cover molding and copilot seat could result in an engine overspeed condition. Foreign objects (seat belts, books, clipboards, etc.) forced down in between the center cover molding and copilot seat could cause the plastic molding (center cover) to move into the throttle linkage. As the throttle is opened, the throttle bellcrank slides against the plastic molding. Eventually, a throttle setting may be reached where the edge of the plastic molding slips underneath the bellcrank arm which could lock the throttle in an open position and result in an overspeed condition.

Part II of this Service Information Notice provides instructions for the installation of a larger center cover support bracket. This larger bracket has been designed to provide addition support between the center cover molding and the throttle linkage. The flanged portion of the bracket helps to ensure proper installation of the center cover molding. This larger bracket is currently being installed on model 269C Production Helicopters and SAC highly

- o The following procedure provides instructions to install either support bracket (269A9928-5 and 269A9928-7). Refer to Figure 1, Detail A when installing 269A9928-7 bracket (Modified Retrofit Kit) or Figure 1, Detail B when installing 269A9928-5 bracket (Retrofit Kit)
- o The existing support bracket does not need to be removed in order to install the improved support bracket on Model 269C Helicopters with Serial Numbers of 1150 through 1299. As shown in Figure 1, Detail A, the retrofit bracket fastens to the existing support bracket.

- (1) Remove AFT RIVET from seat bottom. (Refer to Figure 1 for location of AFT RIVET.)
- (2) Hold bracket in position between seat back and seat bottom as shown in Figure 1.
- (3) Transfer AFT RIVET hole location from seat bottom to mounting flange of support bracket.

- (4) Hold bracket firmly in position and drill a hole through bracket upper mounting surface and seat back. Secure bracket to seat back with cleco fastener.
- (5) Drill hole through bracket forward mounting flange and through seat bottom; secure bracket to seat bottom with cleco fastener.
- (6) Ensure that bracket is in proper position before continuing with the installation.
- (7) Drill remaining holes and secure bracket to seat structure with appropriate rivets at locations shown in Figure 1, Detail A (Retrofit Kit) or Detail B (Modified Retrofit kit), as applicable.
