# SCHWEIZER SERVICE INFORMATION NOTICE

N-219  
24 Aug 1990

SUBJECT: DETAILED INSPECTIONS OF UPPER PULLEY STACK-UP

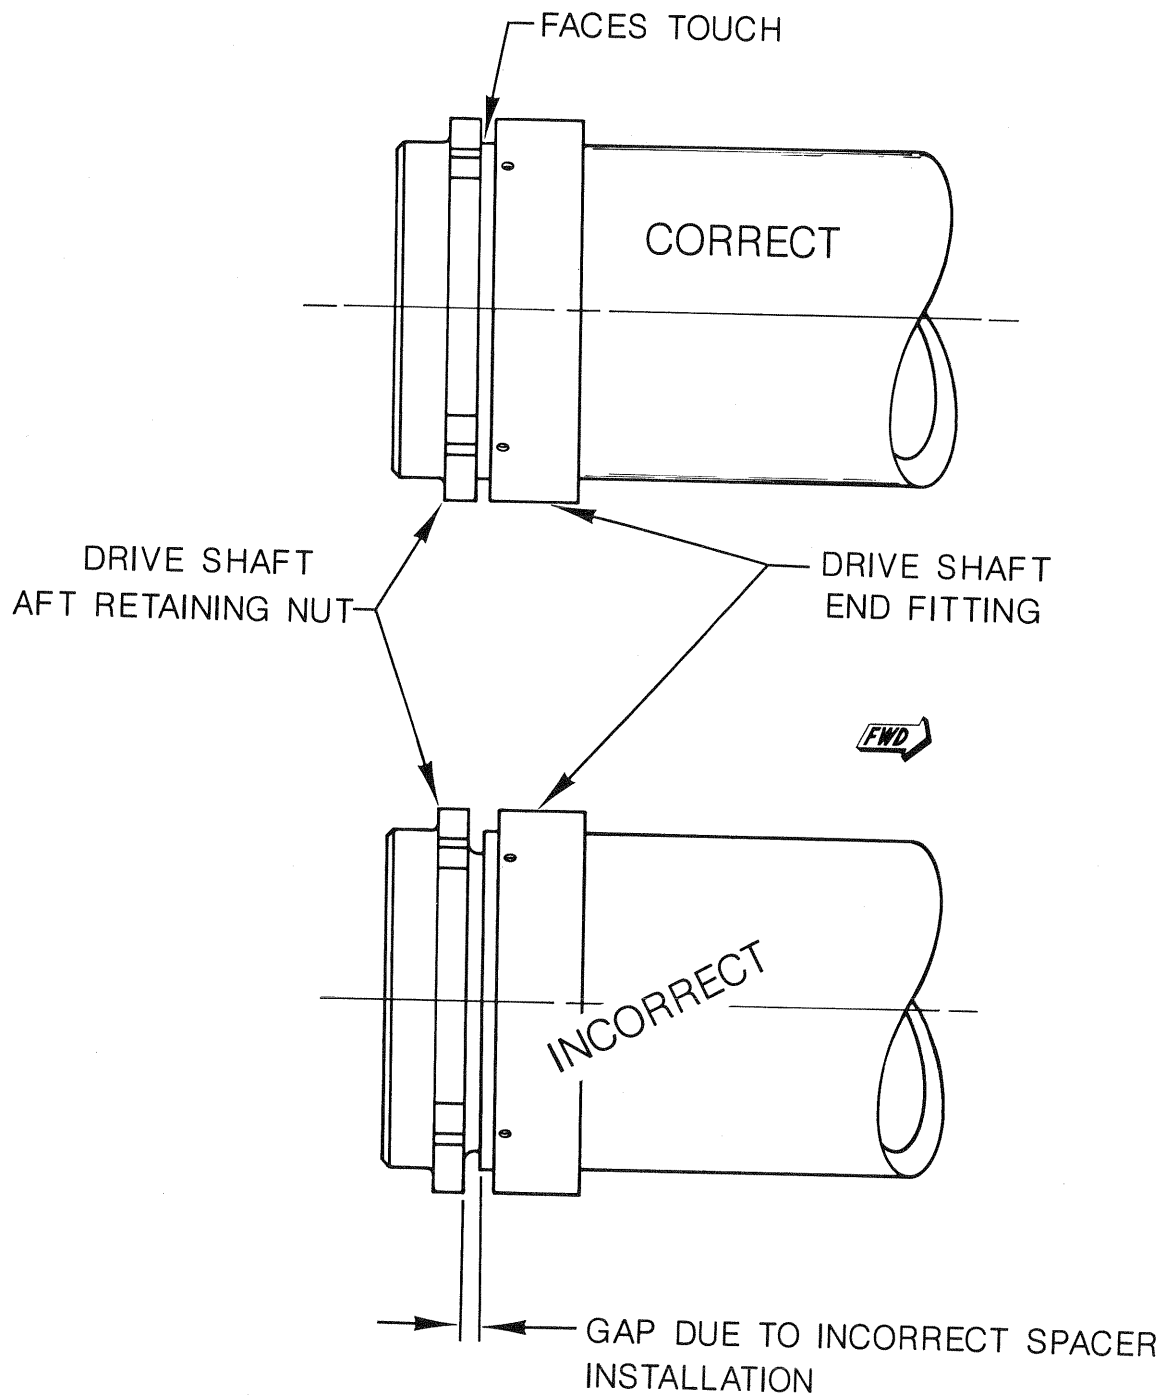
Figure N-219-1. Determining Proper Orientation of Driven Spline Spacer

It is possible for the driven spline spacer (HMICIII, Figure 2-1, Item 19) to be installed backwards. When installed in proper orientation, the wider OD portion of the spacer is aft (HMICIII, Figure 2-1).

- d. Verify that driven spline spacer is installed in proper orientation (Figure N-219-1). Proper orientation of this spacer may be verified by inspecting the drive shaft aft retaining nut and drive shaft end fitting. (If tail rotor drive shaft and transmission are installed, look through the inspection hole.) If installed properly, proceed to step f. below.
- e. If driven spline spacer is NOT installed in proper orientation, remove tail rotor transmission from helicopter (BHMI, Section 10), remove and reinstall driven spline spacer in proper orientation (HMIC).
- f. If removed, reinstall assembled tail rotor drive shaft and transmission (BHMI, Section 10). Connect tail rotor control rod to tail rotor swash plate bellcrank assembly (BHMI, Section 9).
- g. Record compliance with Part I in the aircraft records.

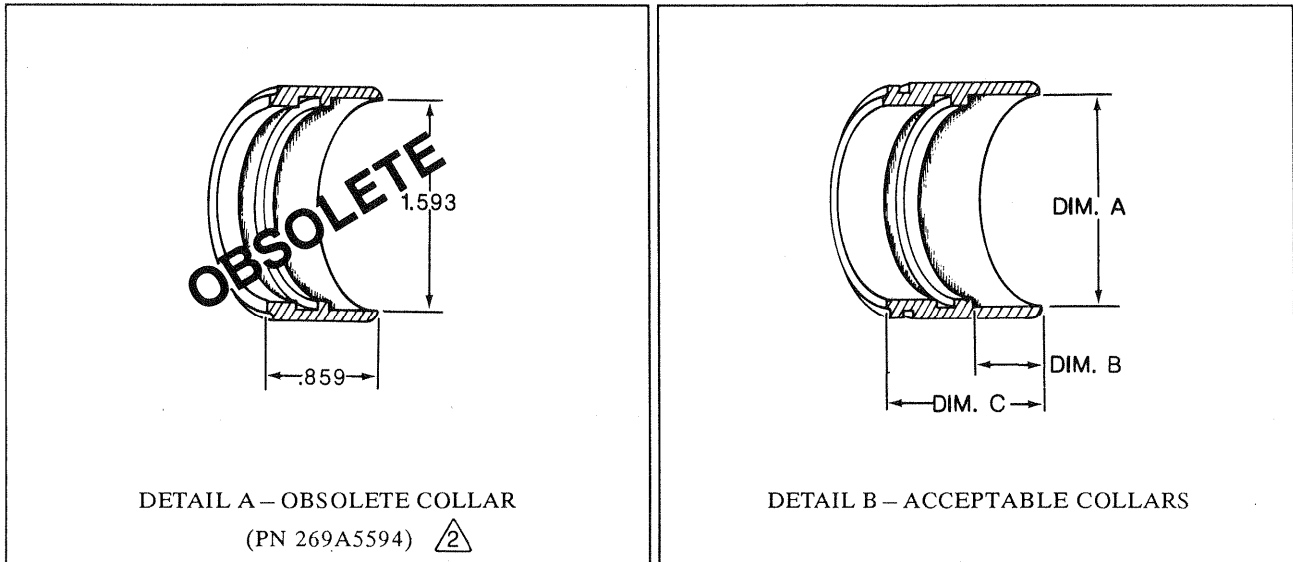
Figure N-219-2. Identification and Compatibility of Pinion Oil Seal Collar

$\triangle$ 2 269A5594 Collar must be removed and replaced with an approved alternate as specified in above table.

- a. Remove belt drive transmission and forward upper H-frame bearing from helicopter (BHMI, Paragraph 10-37).
- b. Use the dimensions listed on Figure N-219-2 to identify collar.
- c. If collar is identified as a 269A5594 collar, remove and discard collar. Order a new 269A5178-9 collar for replacement or consult Figure N-219-3 for an approved alternate collar. Conspicuously mark or tag 269A5594 collar to prevent inadvertent return to service.

- d. On helicopters which incorporate 269A5103-21, -31, -41 or subsequent dash (-) number pinion assembly, order 269A5178-9 collar for replacement. (Refer to Figure N-219-3 for an approved modification to 269A5178-3 collar as an alternative to ordering new collar.)

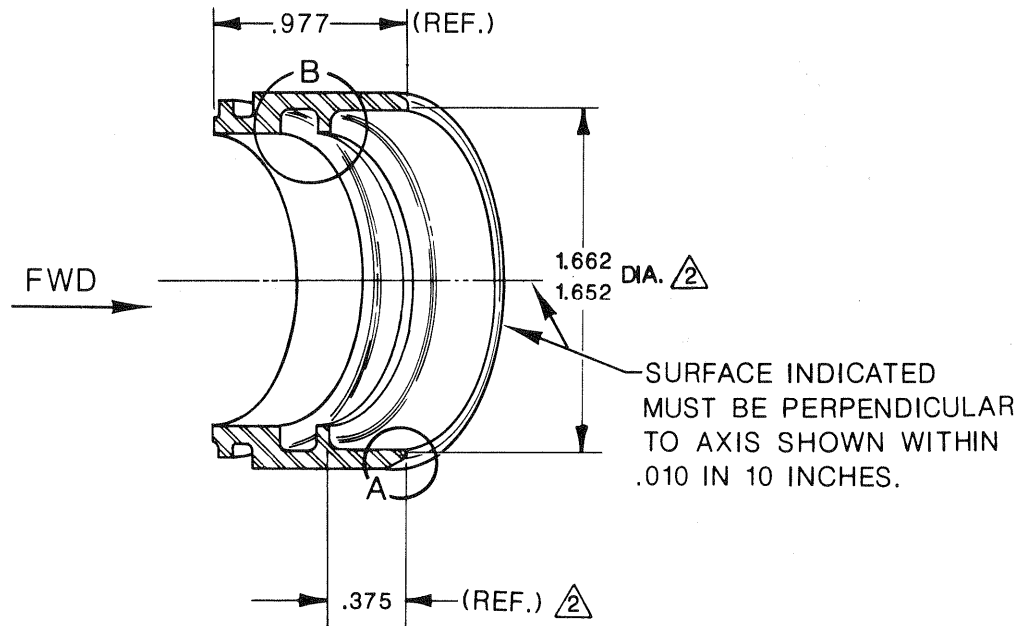
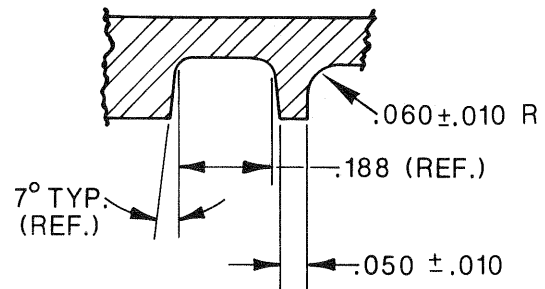
Figure N-219-3. Modification of 269A5178 Pinion Seal Collar to 269A5178-11 Configuration

CAUTION: DAMAGE TO UPPER PULLEY COMPONENTS MAY OCCUR IF MODIFICATION IS IMPROPERLY PERFORMED.

1. ALL DIMENSIONS IN INCHES.
- $\triangle 2$  MODIFY EXISTING -3 COLLAR BY MACHINING FORWARD END I.D. TO DIMENSIONS SHOWN. I.D. OF COLLAR TO BE 1.657±0.005 IN. DEPTH OF BORE TO BE AS REQUIRED TO ACHIEVE .050 DIM. SHOWN IN DETAIL B.
- $\triangle 3$  MACHINE .030/.040 RADIUS 360° AROUND FORWARD END I.D. OF COLLAR AS SPECIFIED BY DETAIL A. RADIUS MUST BE BLENDED SMOOTHLY INTO CHROME SURFACE ON O.D. OF PART. NO CRACKING, CHIPPING, OR FLAKING PERMITTED.

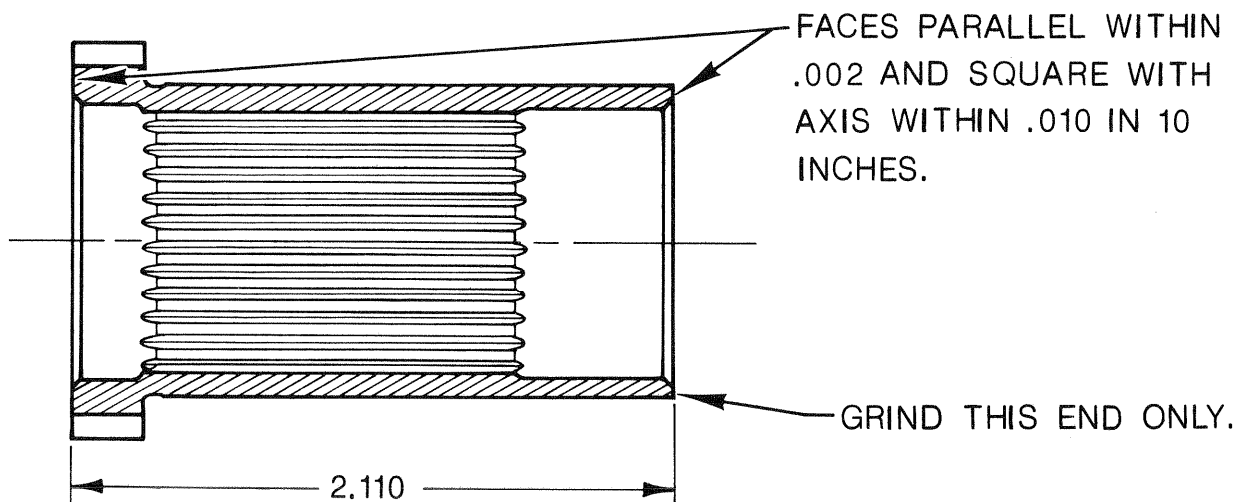
Figure N-219-4. Modification of 269A6030 Driven Spline

**269A6030 (BSC) Spline is nitrided and is very hard. Grind slowly and carefully. Avoid heat build-up and associated grinder burns. If any discoloration of the material is noted, discontinue grinding, allow the material to cool, then resume grinding at a slower rate that will avoid discoloration. When grinding is completed, there must be no discoloration evident on the finished part.**

- d. Either modify existing 269A6030 (BSC) driven spline to a 269A6030-3 configuration (Figure N-219-4), or order a 269A6030-5 driven spline from SAC.

2. MODIFY EXISTING 269A6030 (BSC) DRIVEN SPLINE BY GRINDING INDICATED END OF SPLINE TO DIMENSION SHOWN. MAINTAIN PARALLELISM AND SQUARENESS REQUIREMENTS SPECIFIED ABOVE.
3. UPON COMPLETION OF MODIFICATION, MAGNETIC PARTICLE INSPECT DRIVEN SPLINE FOR DEFECTS. IF ANY DEFECTS ARE REVEALED, REPLACE DRIVEN SPLINE WITH A SERVICEABLE 269A6030-3 OR 269A6030-5 DRIVEN SPLINE.
4. TOUCH UP MACHINED (AFT) END OF DRIVEN SPLINE WITH PRESTO BLACK.
5. RE-IDENTIFY THE MODIFIED DRIVEN SPLINE AS P/N 269A6030-3 USING PERMANENT INK.
