HUGHES SERVICE INFORMATION NOTICE

NOTICE NO. N-58

SUBJECT: INSPECTION-TAIL ROTOR BLADE ASSEMBLY,
P/N 269A6124

MODELS AFFECTED: All 269 Series Helicopters equipped with tail rotor blade assembly having Serial Number 126-3312 or lower.

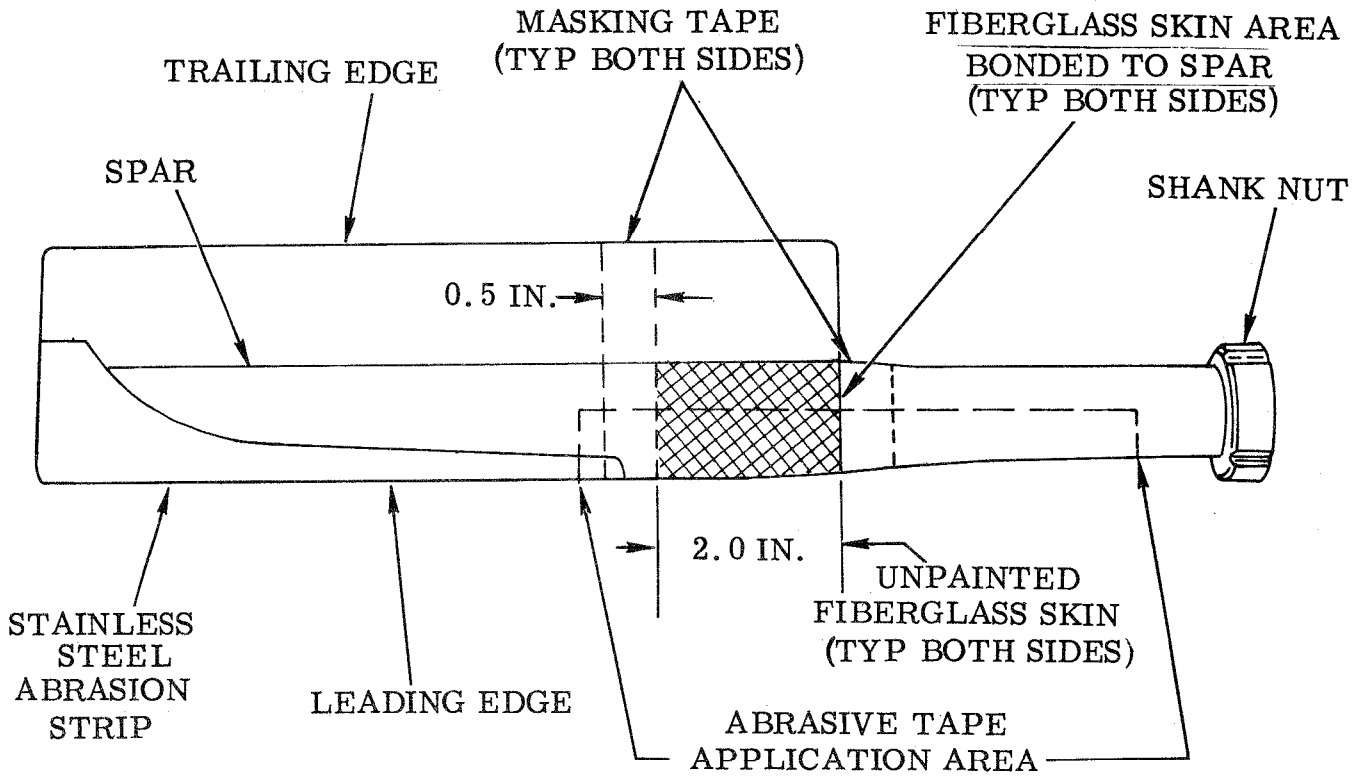
FIGURE 1. INSPECTION-TAIL ROTOR BLADE ASSEMBLY

d. Visually inspect the unpainted area of the fiberglass skin which covers the steel spar, for evidence of voids. (See shaded area, Figure 1)

- (1) More than one void is found in the unpainted area of the fiberglass skin.
- (2) Size of void exceeds 0.50 square inch in area or 1.00 inch in length.

A void is identified by a white or yellow appearance in the fiberglass skin. Normal bond will show the dark gray or black of the steel spar through the fiberglass skin. Record measurement of acceptable void for recheck at subsequent 25-hour inspection.

- a. Visually inspect the unpainted area of the tail rotor blade fiberglass skin which covers the spar, for evidence of voids. (See shaded area, Figure 1)

- (1) More than one void is found in the unpainted area of the fiberglass skin.
- (2) Size of void exceeds 0.50 square inch in area or 1.00 inch in length.
- (3) Void found within acceptable criteria at previous inspection has since propagated or increased in size.

a. Carefully peel existing abrasive tape from both tail rotor blades. (See Figure 1).

b. Apply masking tape, per dimensions shown, to both sides of tail rotor blade fiberglass skin assembly and around spar.

c. Using cloth dampened in solvent, wipe and remove paint from fiberglass skin area two inches from inboard edge on each side of the tail rotor blade; remove masking tape.

Remove and retire tail rotor blade from service, if either of the following is noted:

- e. Install new abrasive tape to tail rotor blades, per HMI.
