HUGHES SERVICE INFORMATION NOTICE

NOTICE NO N-62.1*
DATE August 4, 1971
PAGE 1 OF 6

SUBJECT: KIT - FLOOR BEAM REINFORCEMENT

MODELS AFFECTED: 269A Helicopter Serial Nos. 0011 thru 0884
269A-1 Helicopter Serial Nos. 0001 thru 0041
269B Helicopter Serial Nos. 0001 thru 0471

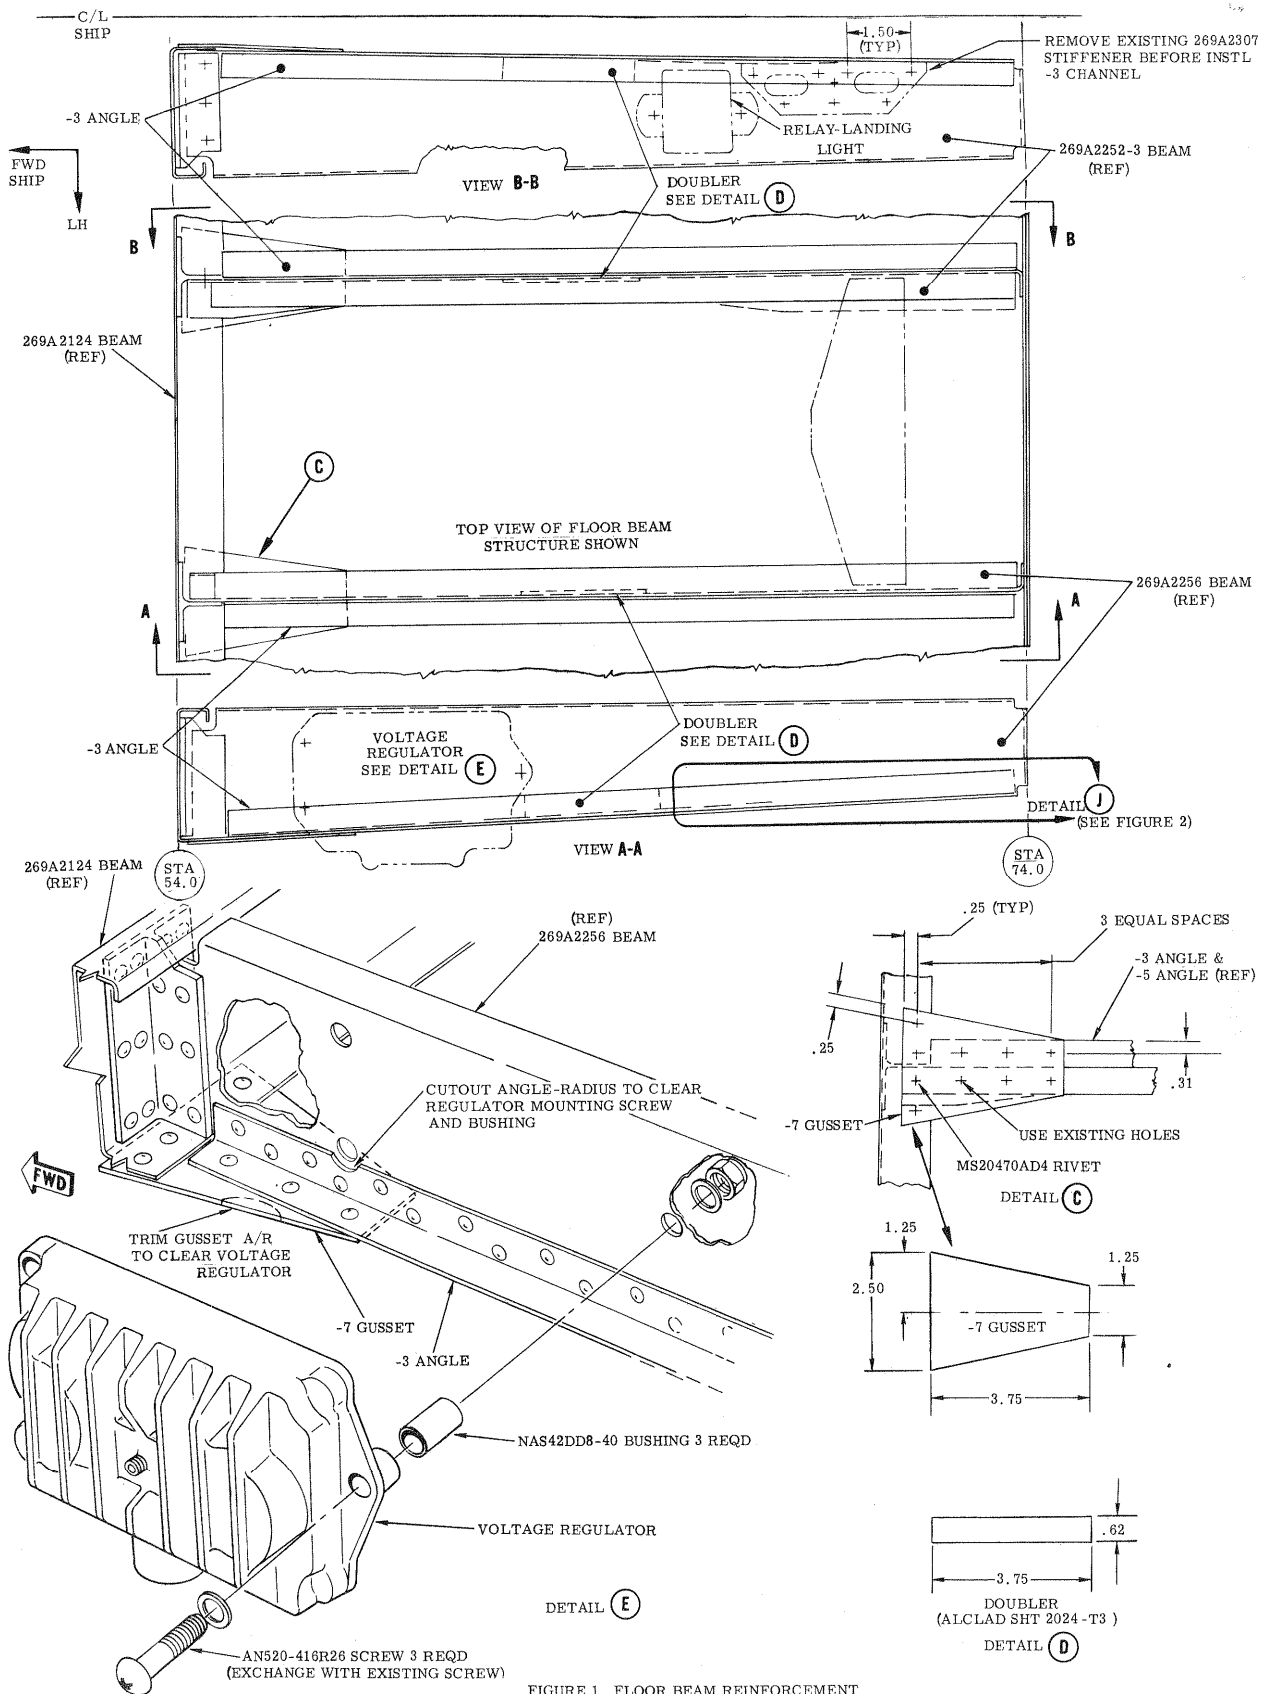
FIGURE 1. FLOOR BEAM REINFORCEMENT

PREFACE: The information given in this Service Information Notice lists a procedure for rework of the cabin floor beams aft of the rudder pedal controls. Installation of stiffeners increases the structural stability of the floor supports, and ensures adequate floor beam strength to withstand heavy foot or leg forces exerted by instructor pilot when overriding student operating rudder pedal controls.

- a. Remove lower forward fairing; disconnect air filter inlet; cover carburetor/injector inlet to prevent entry of foreign objects.
- b. Remove landing light relay installed on 2252-3 beam (LH side) (Refer to Figure 1). or 2256 beam (RH side) (Refer to Figure 2). Also remove radio power supply unit, if presently installed on beams.

- c. Remove voltage regulator installed on 2256 beam (LH side). (Refer to Figure 1).
- d. Using #30 drill, remove rivets securing existing gussets at junction of 2124 and 2252-3 beams (2 places) and at junction of 2124 and 2256 beams (2 places).

j. Position -7 gusset (4 places) as shown at junction of 2124 and 2252-3 beams and 2124 and 2256 beams. Mark and drill holes in beams and install gussets with rivets. Use existing rivet holes in beams. (Refer to Figure 1).
