**HUGHES
SERVICE INFORMATION
NOTICE**

NOTICE NO. N-78

SUBJECT: INSPECTION - P/N HS1446-10-68 BOLT,
LEAD LAG AND FLAPPING HINGE

MODELS AFFECTED: All 269A, 269A-1, 269B and 269C Helicopters
delivered prior to August 1, 1970

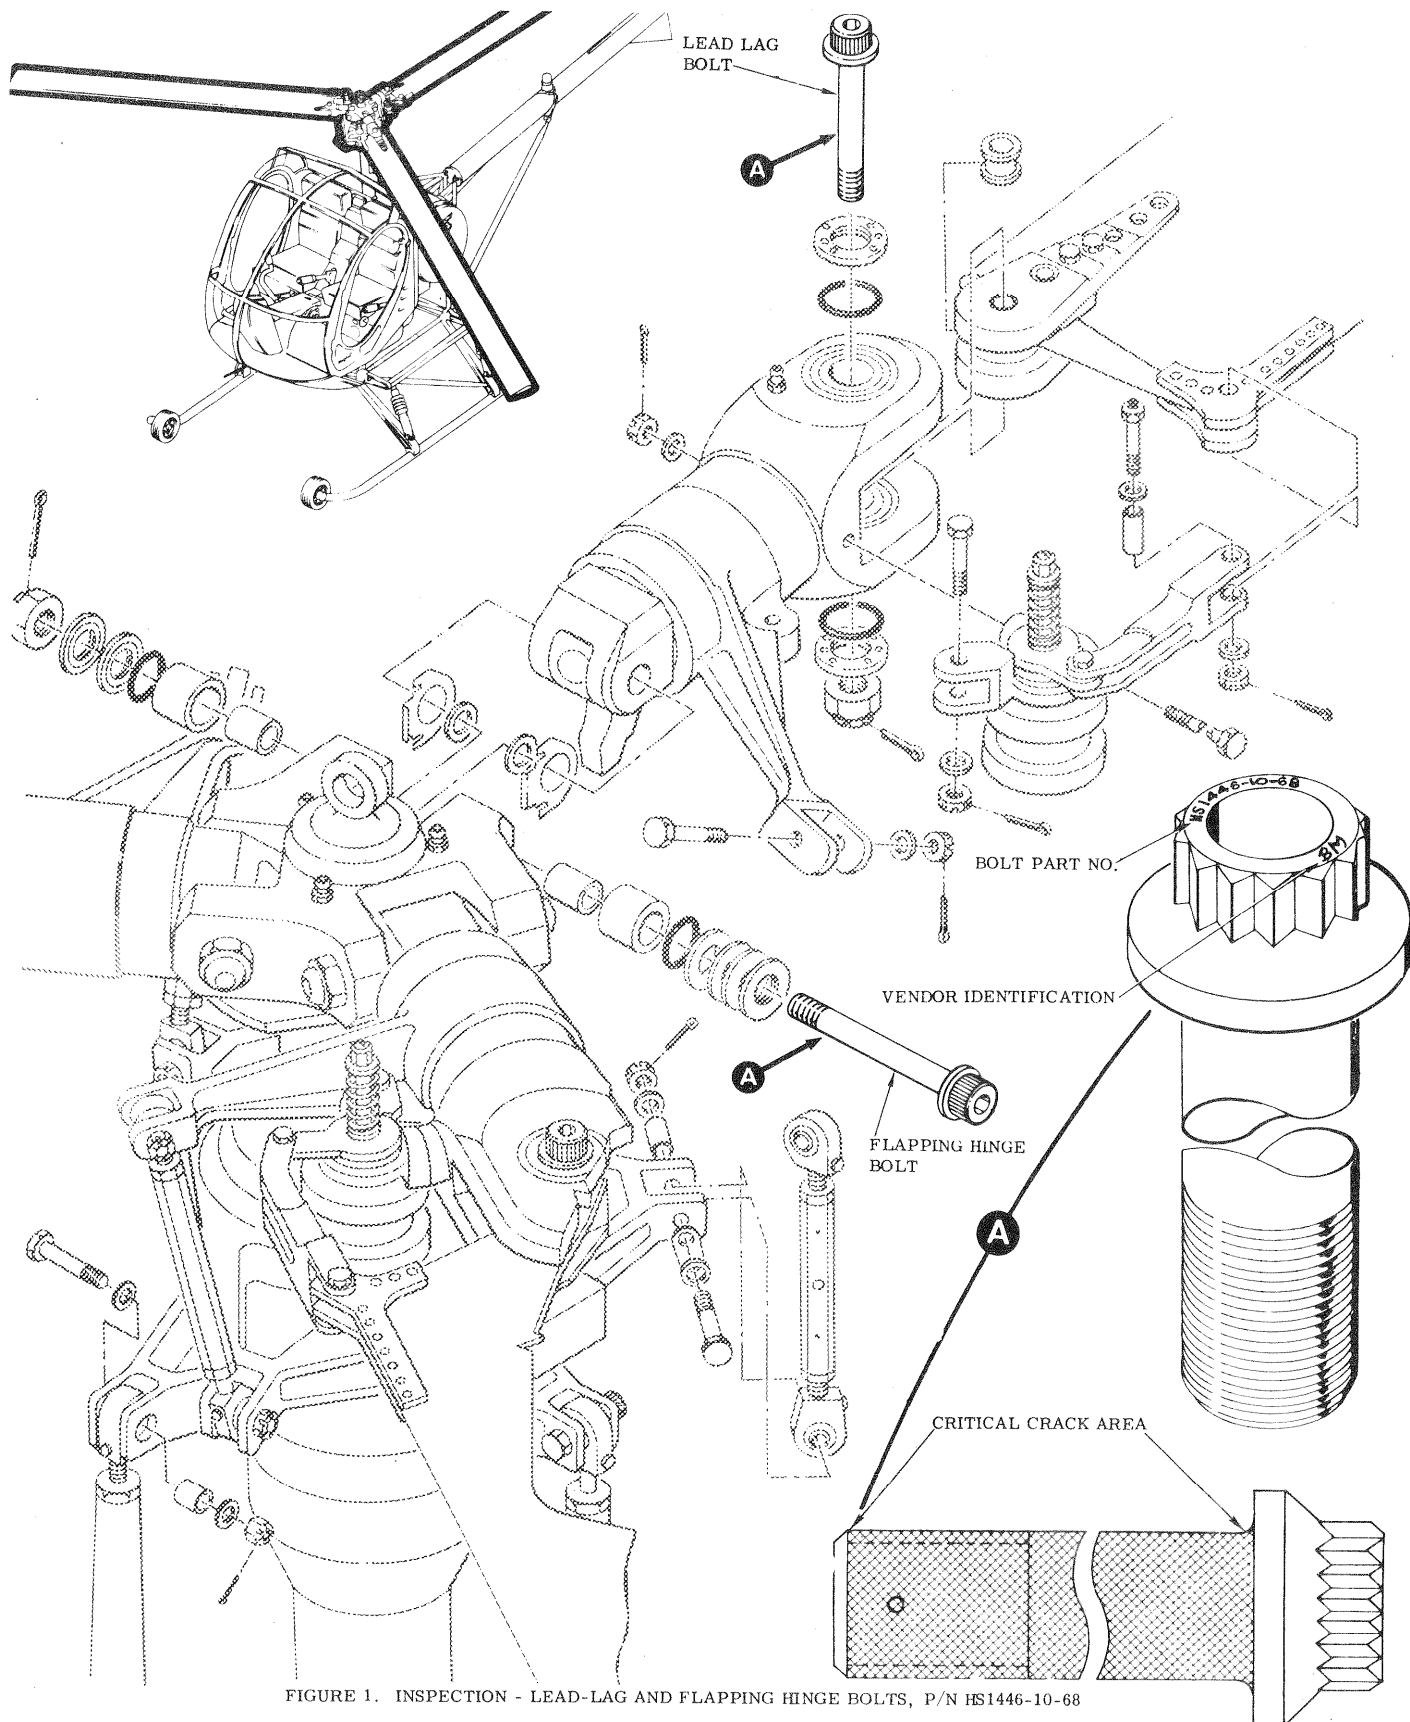
FIGURE 1. INSPECTION - LEAD-LAG AND FLAPPING HINGE BOLTS, P/N HS1446-10-68

- a. Visually inspect (6) lead lag and flapping hinge bolts (Model 269C lead lag bolts only) to determine if vendor identification BM is impression stamped on bolt head. (See figure 1)
- b. Remove bolts identified BM and not having head dyed green from rotor head. (Refer to applicable HMI)
- c. Magnaflux inspect removed bolts for evidence of cracking.
 1. If cracks are noted, retire bolt, identify as unserviceable, and notify HTC; install serviceable bolt prior to next flight.
 2. If no cracks are found, apply white paint dot in bolt head recess and return bolt to service.
