SCHWEIZER SERVICE NOTICE

NOTICE NO. N-82.3*

SUBJECT: INSPECTION - TAILBOOM CENTER ATTACH FITTING (PN 269A2324),
AND CENTER FRAME AFT CLUSTER FITTINGS (PN 269A2234 AND
269A2235)

MODELS AFFECTED: All 269A, TH-55A, 269A-1 and 269B helicopters equipped
with subject fittings
269C helicopter Serial No. 0004 through 0569 equipped with
subject fittings

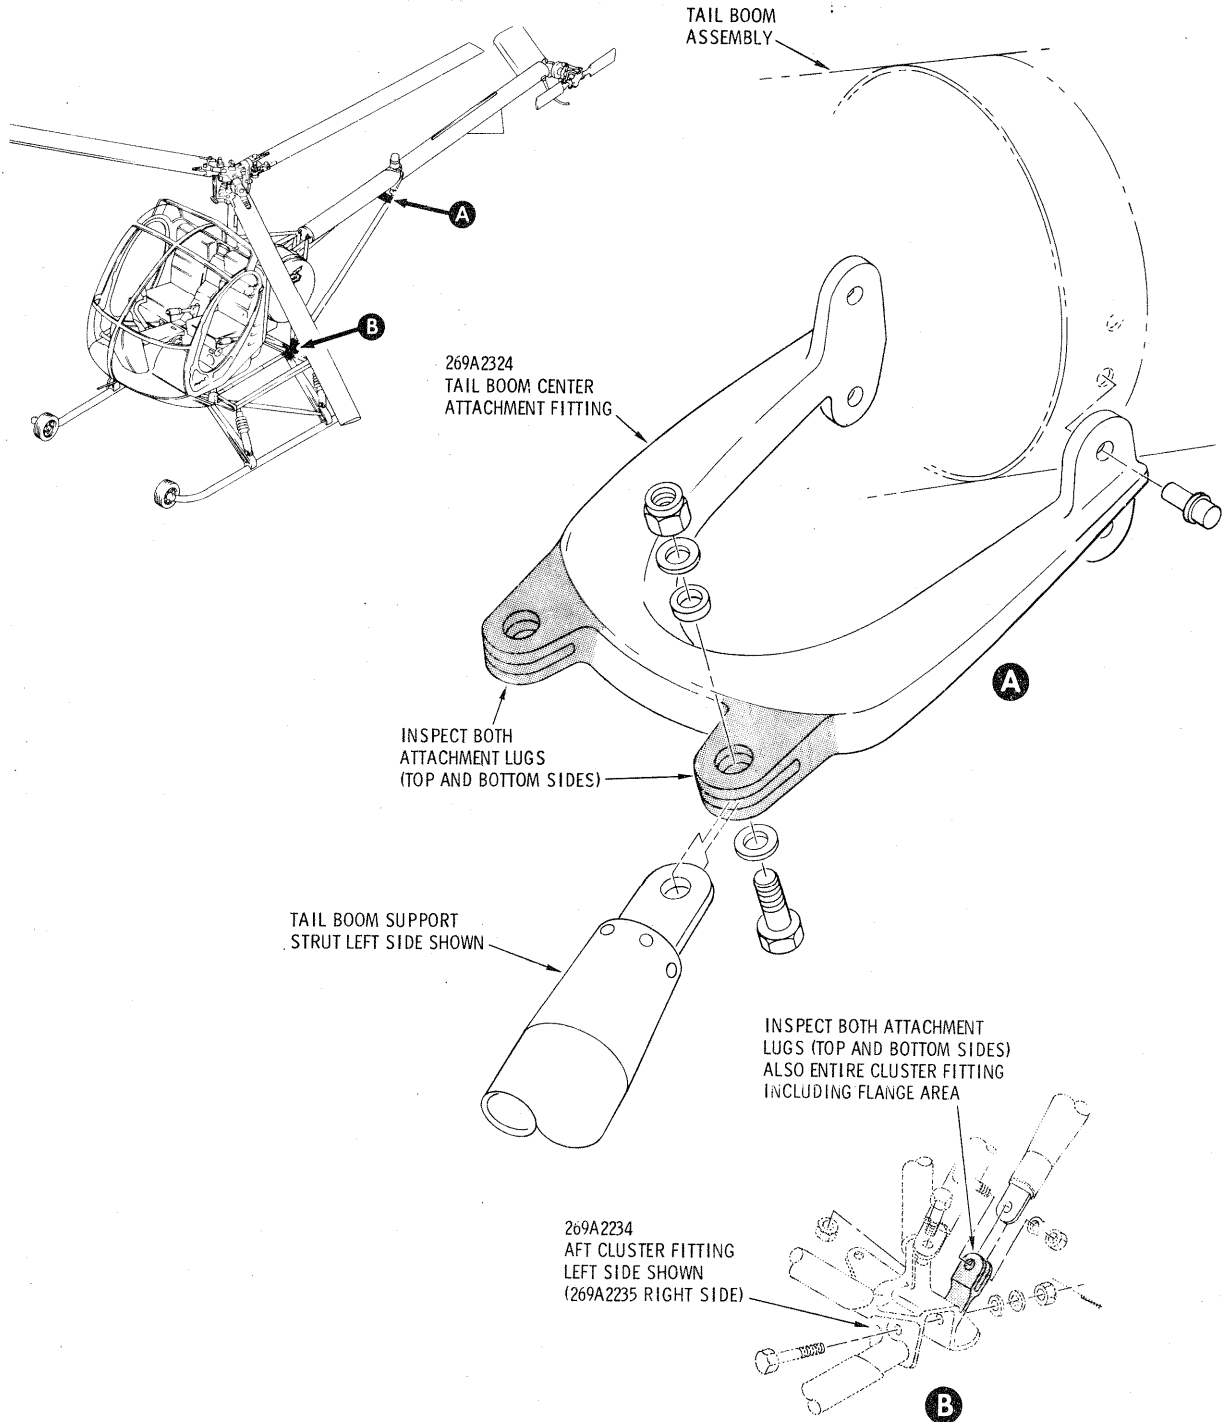
Figure 1. Inspection - tailboom center attach fitting, and center frame section aft cluster fittings

c. Apply dye penetrant solution to attach lugs of tailboom center attach fitting, and to center frame aft cluster fittings. Using 10X magnifying glass, inspect for cracks and other structural damage. (See Figure 1.)

Refer to Step III of this Notice for weld repair criteria for cracks occurring in flange area of aft center frame cluster fittings. Only cracks in the flange area on outboard side of fitting may be repaired. Cracks in any other area require fitting replacement per Step II. (See Figure 1.)

d. Immediately retire from service and tag as unserviceable any tailboom center attach fitting found to have cracks or other structural damage. The 269A2324-7 center attach fitting MUST be used for replacement.

e. Immediately retire from service and tag as unserviceable any aft center frame cluster fitting found to have unrepairable cracks or other structural damage. The 269A2234-3 and/or 269A2235-3 aft cluster fittings MUST be used for replacement where required.
