SCHWEIZER SERVICE NOTICE

NOTICE NO. N-9.2
DATE 3 October 1977
PAGE 1 OF 7

SUBJECT: INSPECTION - POSSIBLE RETIREMENT, MAIN ROTOR BLADE

MODELS AFFECTED: All 269A, 269A-1, 269B and TH-55A Helicopters

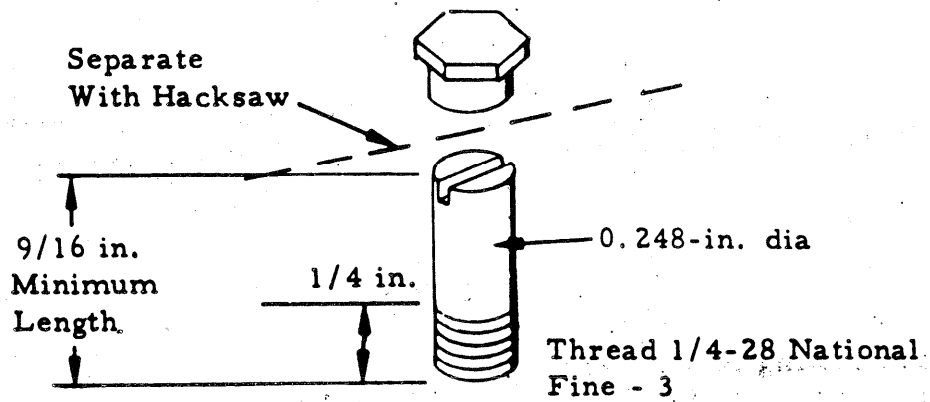
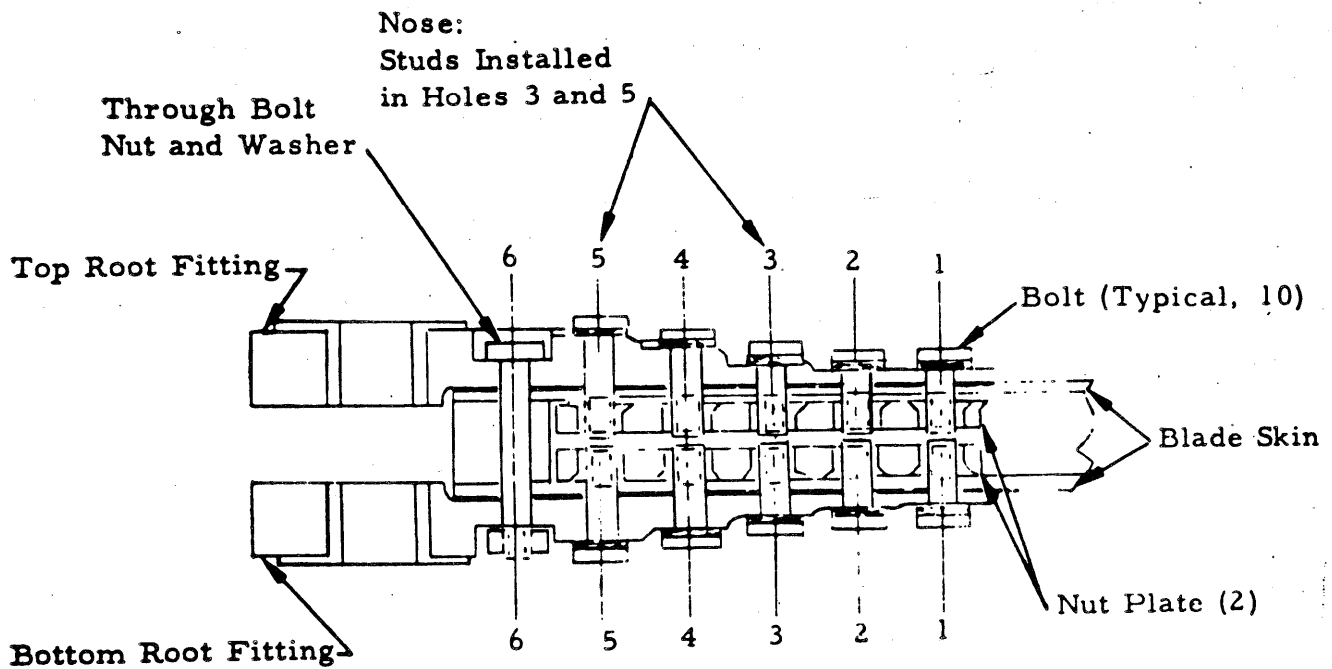
Figure 1. Main Rotor and Root Fitting Cross Section

d. Remove root fitting retaining bolts 3 and 5 from top of blade (See Figure 1).

- a. Using hacksaw, remove heads from two NAS bolts.
(See Figure 1)
- b. Using hacksaw, cut screwdriver slot on unthreaded end of bolt and deburr.
- c. Determine that compliance with requirements of Service Information Notices N-46 dated 18 April 1968, or N-47 dated 18 April 1968 has been accomplished.

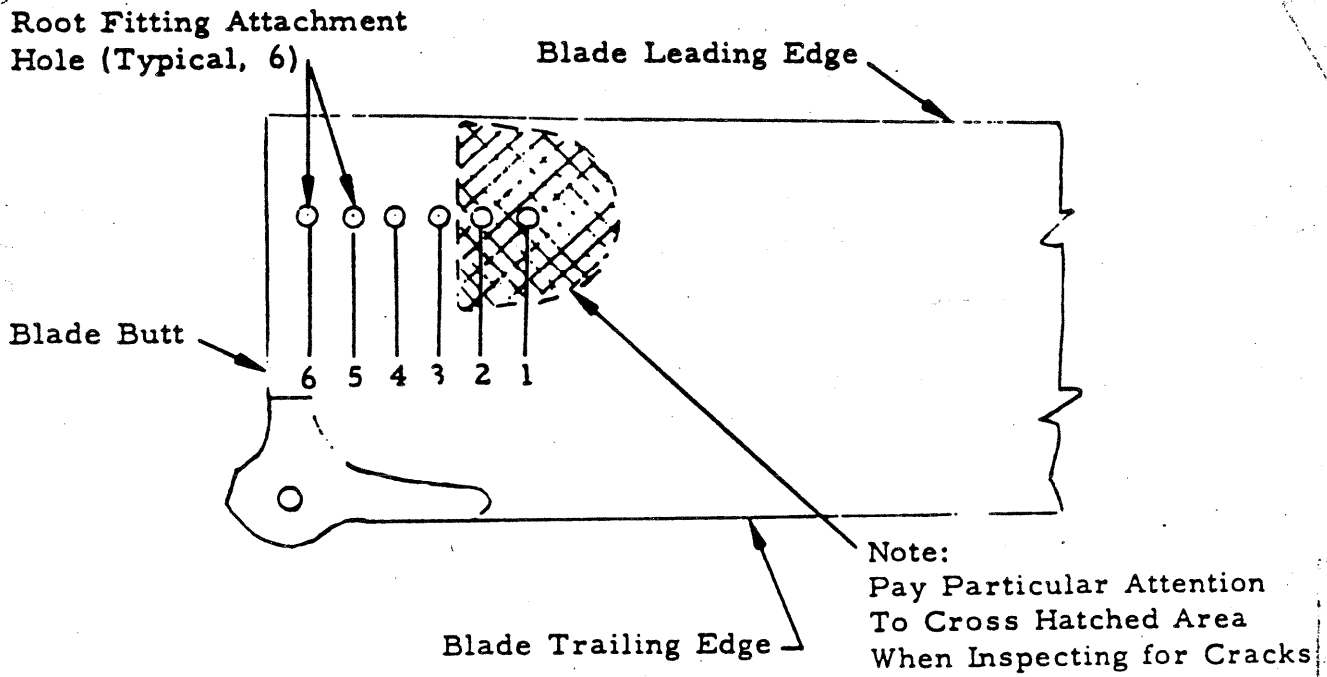
Figure 2. Main Rotor Blade Root Fitting Removed

When inspecting the areas of the blades defined in the following steps, use the magnifying glass. The inspection should be performed in direct sunlight or by using the floodlight. When using the floodlight, varying the position may be helpful. Any evidence of cracking is cause for retiring the blade from service. Cracked blades should be marked to prevent inadvertent return to service.

j. Inspect for cracks, holes 1 through 6, paying particular attention to 1 and 2. (See Figure 2)

While inspecting the blade holes for hairline cracks, examine the area at the forward and aft sides of the holes; and at both the skin surfaces and the inside of the hole itself, including the spar.

1. If blade/ blades are not cracked, reinstall root fitting and bolt/washer combinations in reverse order of removal, noting the following additions; torque bolts 55 to 60 inch-pound.
 1. Align root fitting and phenolic spacer on blade using nut plate retainer studs.
 2. Install bolt/washer combination carefully, to prevent binding or galling of holes, nut plates, and bolt.
 3. Torque bolts alternately; that is, 1 to 6, 2 to 5, 3 to 4.
- m. Install main rotor blades on rotor craft. (Refer to HMI)
