HUGHES SERVICE INFORMATION NOTICE

NOTICE NO. N-98

INSPECTION - TAIL ROTOR CONTROL STOP,

P/N 269A7326

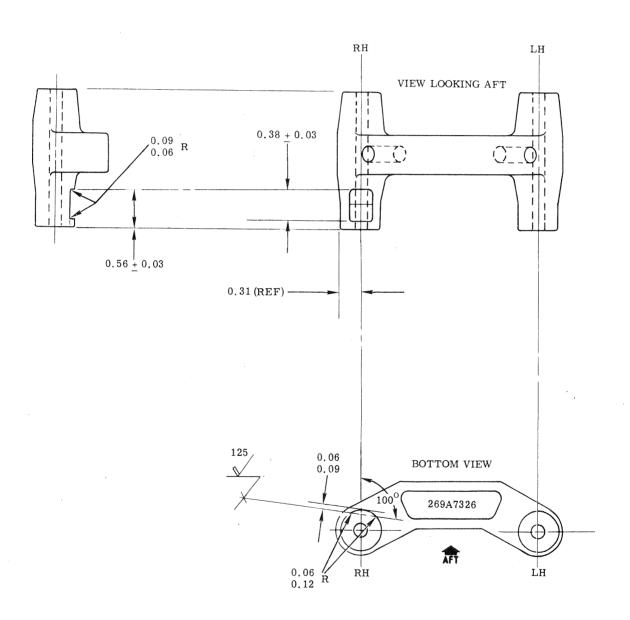
Figure 1. Rework - Tail Rotor Control Stop, P/N 269A7326

The information given in this Service Information Notice lists a procedure for a one-time inspection of the P/N 269A7326 tail rotor control stop, to determine if interference exists between the control stop and the tail rotor control cable. A procedure for rework and modification of the control stop is included, to eliminate any interference that may exist.

a. Using adequate light source and mirror, inspect tail rotor control stop for evidence of interference or chafing between the control cable and the control stop.

- c. Using rattail file or equivalent, remove material from control stop at localized area shown in Figure 1; remove sufficient material (up to maximum allowed) to eliminate interference or chafing.
