SCHWEIZER SERVICE BULLETIN

DB-035
9 May 2011

SUBJECT: 269D1120 Main Rotor Blade Paint Separation

MODELS AFFECTED: Model 269D Configuration "M" Helicopter (S-333M)

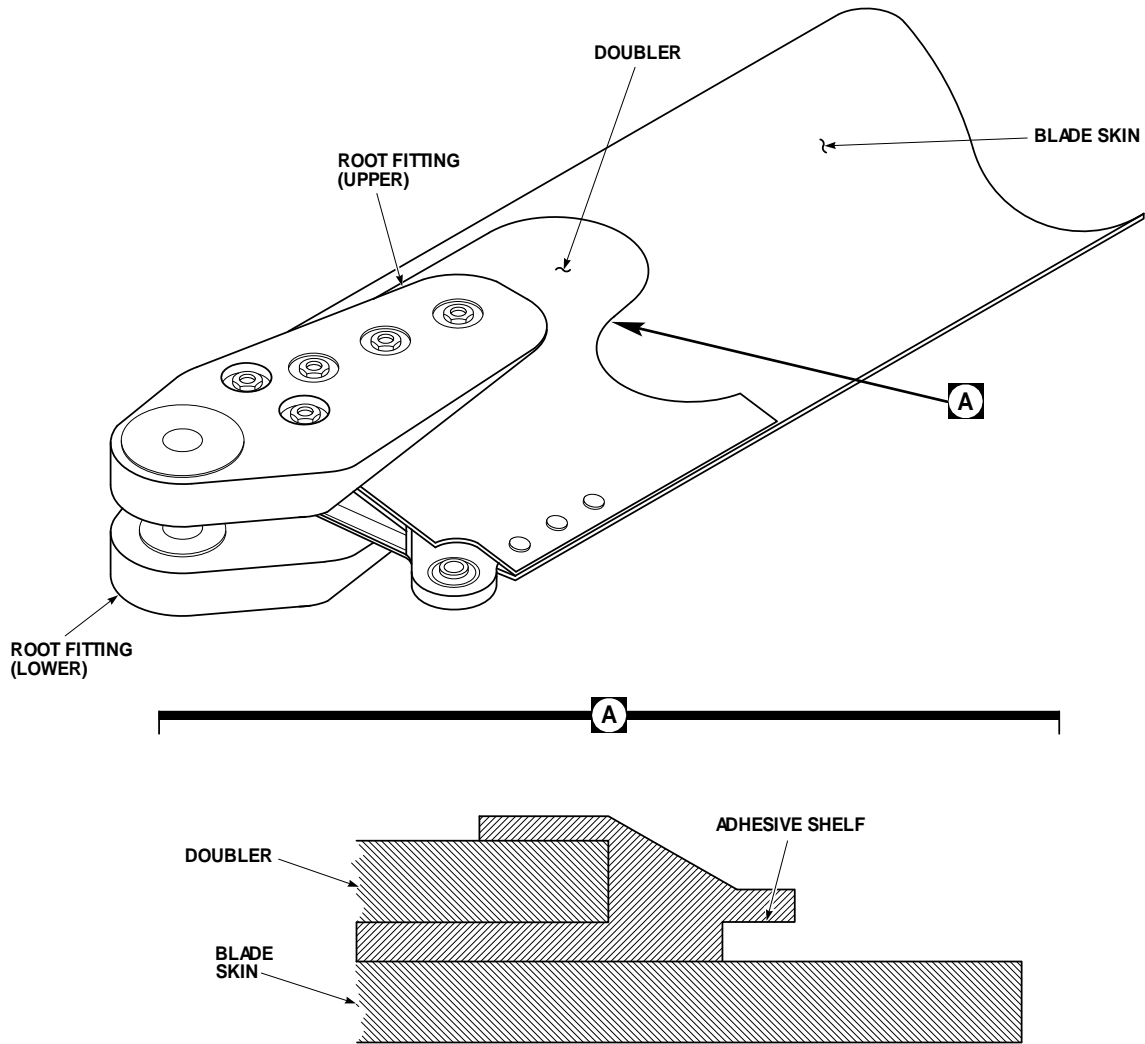
Figure 1. Adhesive Shelf at Interface of Doubler and Blade Skin

During main rotor blade manufacturing, the doubler is bonded to the blade skin. The bonding process may leave a small ridge or "shelf" of dried adhesive along the interface of the doubler and skin (see Figure 1). When the blade is painted this adhesive shelf may give a false appearance of the paint having separated from the blade.
