# 269D™ HELICOPTER

## ALERT SERVICE

ASB DB-045  
BASIC ISSUE ▪ July 25/13

**SUBJECT:** One-Time Engine Alignment Check and Inspection of the KAflex® Drive Shaft, KAflex Coupling Assembly, and Engine Mount Assembly Absorbers

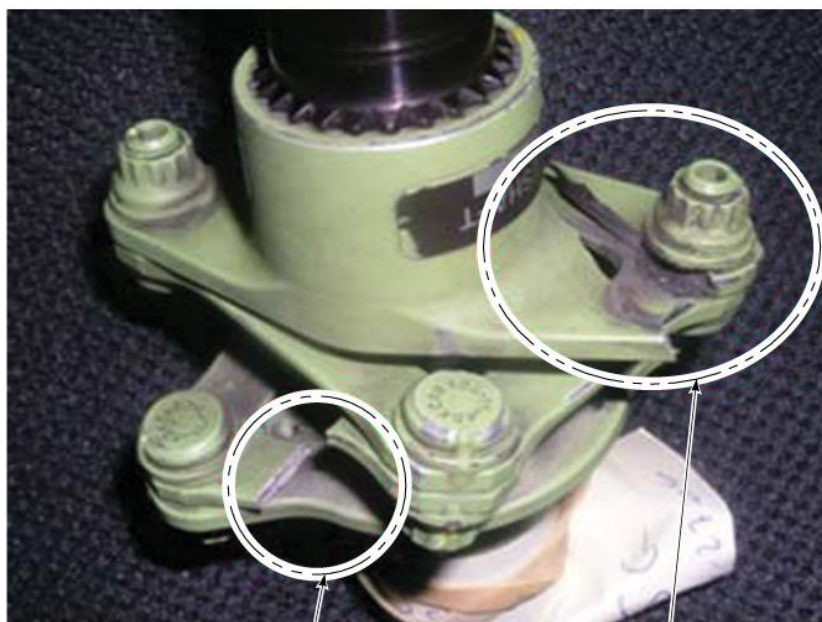
Figure 1. Example of Fractured KAflex Assembly

- (1) Remove KAflex Drive Shaft, and Coupling Assembly. Refer to Table 1 for applicable publication and helicopter model.
- (2) Refer to Figure 1 for example of fractured KAflex Assembly.

AREA OF INSPECTION FOR  
ENGINE COUPLING FLEX FRAME  
(SKCP2537-11)

AREA OF INSPECTION FOR  
ENGINE ADAPTER LUG  
(SKCP2985-11)

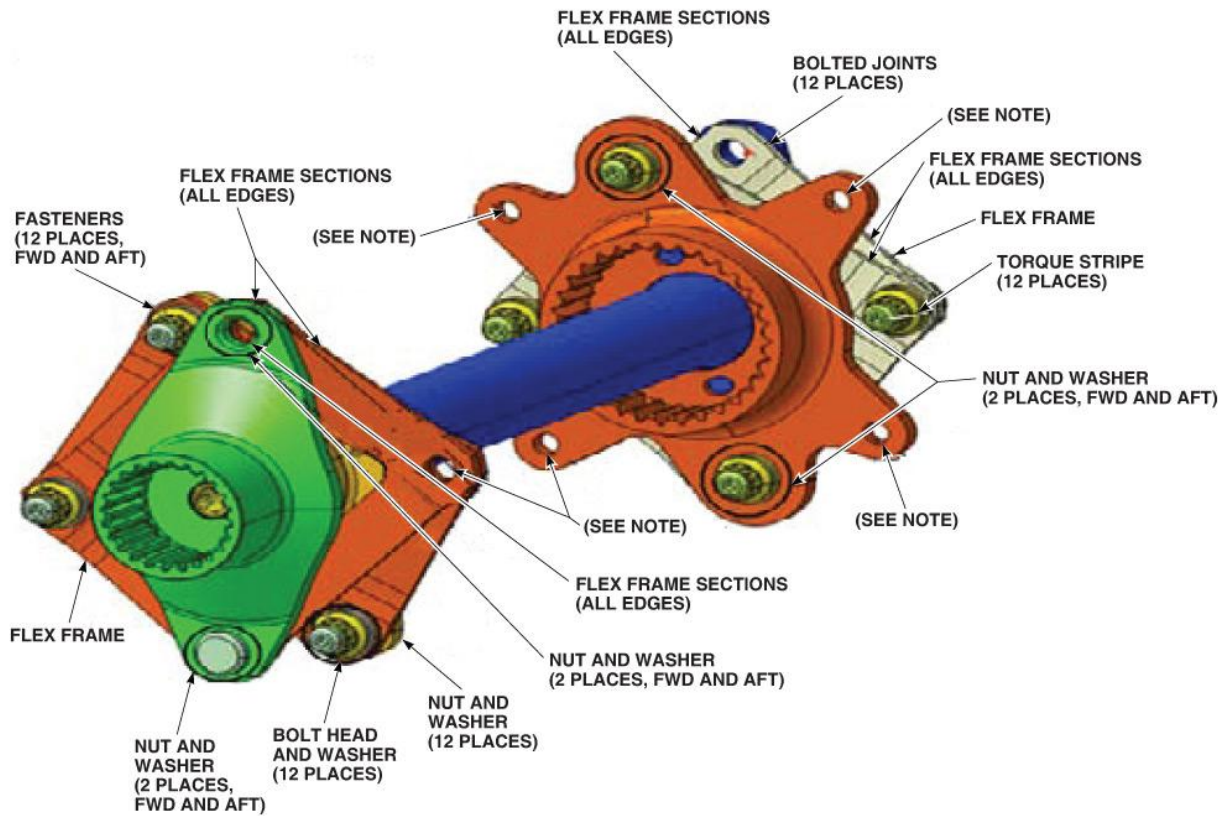
Figure 2. Kflex Assembly Inspection Locations  
 (Image representative of P/N SKCP2738-5/-7, but not identical.)

- (3) Check for working fastener condition at joints by hand (12 places, both sides) – black residue under head or tail. Metal wear will appear as powder (fretting debris) and appear black or red in color. If powder is found, remove the drive shaft from service. Refer to Figure 2 for location of inspection. Record findings in the ASB Work Sheet (Section E).
  - (a) If drive shaft is removed from service, proceed to step (11).
  - (b) If rejected condition is not found, proceed to step (4).

- (4) Visually inspect for cracks emanating from under head and/or tail of fasteners (12 places, both sides). Refer to Figure 2 for location of inspection. Record findings in the ASB Work Sheet (Section E).
  - (a) If drive shaft is removed from service, proceed to step (11).
  - (b) If rejected condition is not found, proceed to step (5).

- (5) Inspect flex frame and mount bolt torque stripes for evidence of movement. If any evidence of movement is found, or torque stripes are no longer visible, remove drive shaft from service. Refer to Figure 2. Record findings in the ASB Work Sheet (Section E).

- (6) Using a 10X magnifying glass or equivalent, visually inspect flex frame bolted joints for evidence of wear. If evidence of wear is found, remove drive shaft from service. Refer to Figure 2. Record findings in the ASB Work Sheet (Section E).

- (7) Using a 10X magnifying glass or equivalent, visually inspect flex frame for evidence of cracks over the full circumference (360 degrees) around the bolt head and washer side and over the full circumference (360 degrees) around the nut and washer side. If any evidence of cracking is found, remove drive shaft from service. Refer to Figure 2. Record findings in the ASB Work Sheet (Section E).

- (a) If drive shaft is removed from service, proceed to step (11).
- (b) If rejected condition is not found, proceed to step (8).
- (8) Using a 10X magnifying glass or equivalent, visually inspect four inside and outside corner radii and radii edges for evidence of cracks on each flex frame. Inspect the corner radii edges on both sides of the flex frame. If any evidence of cracking is found, remove drive shaft from service. Refer to Figure 2. Record findings in the ASB Work Sheet (Section E).

- (a) If drive shaft is removed from service, proceed to step (11).
  - (b) If rejected condition is not found, proceed to step (9).
- (9) Using a 10X magnifying glass or equivalent, visually inspect each shaft end-fitting flange for evidence of cracks over the full circumference (360 degrees) around the nut and washer side. If any evidence of cracking is found, remove drive shaft from service. Refer to Figure 2. Record findings in the ASB Work Sheet (Section E).

- (a) If drive shaft is removed from service, proceed to step (11).
  - (b) If rejected condition is not found, proceed to step (6).
  - (c) If torque stripes have faded, repaint using torque seal or equivalent (Table 3-2, Item 139, OMI MSP-D-15; Table 2-2, item 128, HMI MSP-D-18) in the same location and orientation as previously applied. Refer to Figure 2.
