# SCHWEIZER SERVICE BULLETIN

B-277  
25 Jan 2002

SUBJECT: ONE-TIME INSPECTION OF CERTAIN 269A2234-3 (LH) AND 269A2235-3 (RH) AFT CLUSTER FITTINGS

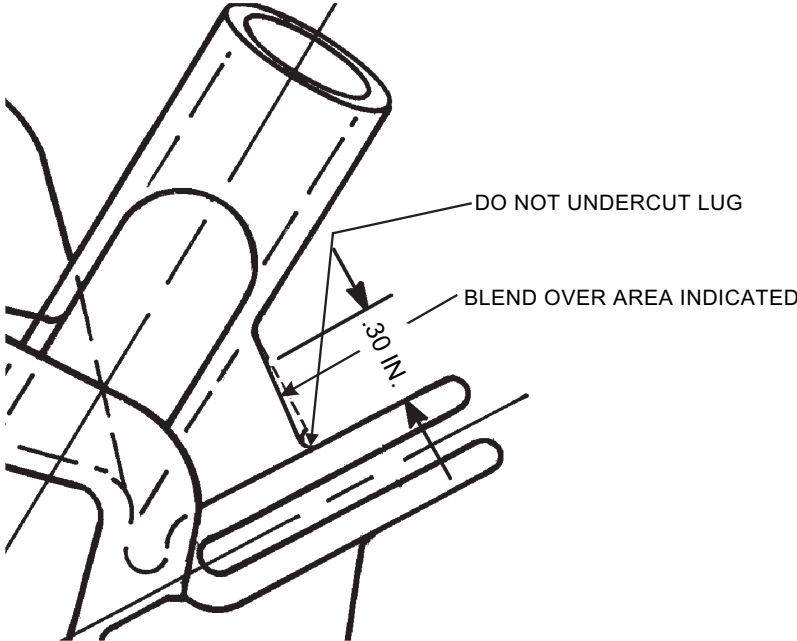
Figure B-277-2. Radius Limitations

- PREFACE:
- Field reports indicate a possibility of cracking of the attachment lug (for tailboom struts) on subject cluster fittings. This cracking may be caused by surface defects (nicks, scratches, and gouges) on the lugs and/or incorrect web radii. This Service Bulletin requires a one-time special inspection to check for cracks and surface defects; and also provides appropriate corrective action. Any cluster fitting that is cracked or has surface defects beyond rework limits must be replaced.
  - Failure to comply with this Service Bulletin may lead to loss of control of the helicopter and subsequent injury, death and/or property damage.

- d. If surface defects are found on lugs, use progressively finer grades of abrasive material to remove defects up to the maximum repairable limits specified in Figure B-277-1. Remove material only as necessary to remove defects. Polish lugs smooth with 320 grade (or finer) abrasive paper.

- e. Measure thickness of lugs; it must be a minimum of 0.115 inch after rework. If lug thickness is less than 0.115 inch, replace cluster fitting (Paragraph 13-44).
